## **BSC Information** Sheet 803

# What's Wrong With This Practice?

# **Unsealed Conditioning Equipment Outside Conditioned Space**

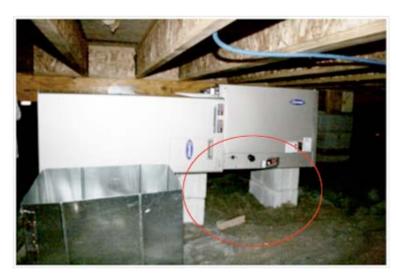
HVAC equipment for house in North Carolina installed in a vented crawlspace over top of damp sand; this is **not** recommended for various energy, moisture and interior air quality reasons.

Conditioning equipment installed in an unconditioned crawlspace (in the example photos) in combination with unsealed returns in the joist spaces.

Installing conditioning equipment in an unconditioned crawlspace or ventilated attic, in combination with unsealed returns in the joist spaces could result in contaminants and moisture being drawn into the conditioning equipment and distributed to the building. In combination with return plenums in floor joists and wall cavities, it is not uncommon for the space conditioning equipment to be unsealed and draw in air from the surrounding environment. During a field investigation it was found that the unsealed return negatively pressurized the basement enough to backdraft combustion air from the water heater. It should be noted that in this case there was a combustion air makeup supply installed as per the building code, but that this makeup air was not enough to overcome the negative pressurization caused by leaky ductwork.

Only fully ducted and sealed returns should be used but it is also important that the air conditioning equipment should also be sealed, especially when located in a vented crawlspace or attic. Air sealing should ideally be done with mastic, or (second choice) tape meeting

UL 181A or 181B.¹ Pressure testing of the entire ducting system and conditioning equipment will determine the amount and location of air leakage with a fan and manometer.

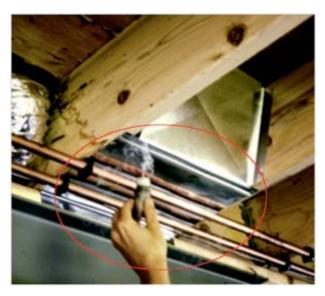
Leaky return plenum drawing in tracer smoke during the field investigation; the system was negatively pressurized enough to backdraft the combustion air from water heater.
