Case Study

Bedford Farmhouse High Performance Retrofit Prototype

Bedford, Massachusetts

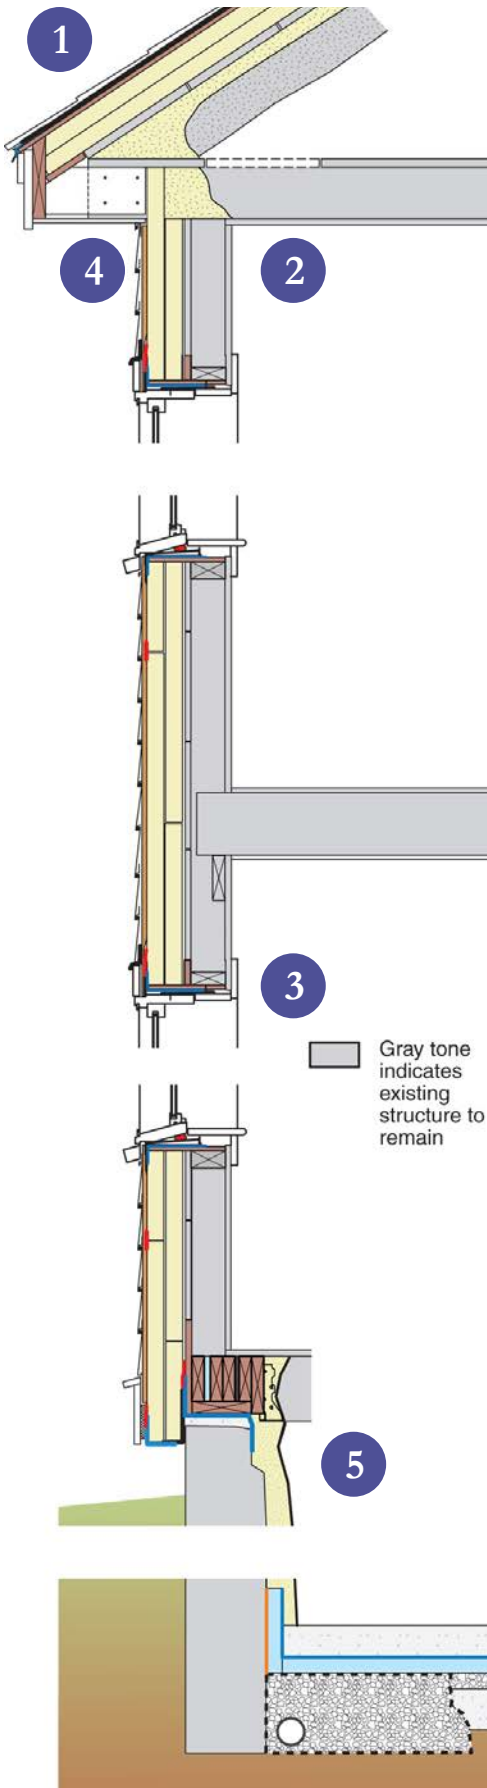
1 Roof Assembly: Rafter-framed unvented attic with R-56 roof insulation: unfaced fiberglass batt insulation (R-30) in rafter bay with two 2" layers of foil-faced polyisocyanurate insulating sheathing (R-26, joints staggered and taped) on top of existing/ repaired roof sheathing.

2 Wall Assembly: Existing wall framing cavities filled with blown-in cellulose insulation (R-14). Spray foam insulation at critical transitions. Two 2" layers of rigid foil-faced polyisocyanurate insulation (R-26)

3 Window Specifications: Andersen Silverline double glazed, Low-E, vinyl windows: U=0.35, SHGC=0.29

4 Air Sealing: The primary air flow control layer is the exterior face of the insulating sheathing with taped seams. Self-adhered membrane and low expansion foam sealants transition the air flow control at windows. Self-adhered ice/water membrane over the entire surface of the roof sheathing provides air flow control at the roof. Low expansion foam is used to transition the air barrier to roof framing and sheathing. Self-adhered membrane flashings transition the air control layer at the base of the above grade wall to the closed-cell foam applied to the interior of the foundation walls.

5 Foundation Assembly: Conditioned basement with 2-3" closed-cell spray foam insulation applied directly to field stone foundation walls and covered with FireFree 88® ignition barrier paint. A 12" high strip of 2" XPS as the slab perimeter thermal break also allows foundation walls to drain to the sub-slab drainage system. Trenches filled with gravel and drainage pipe connected to a sump manage bulk water below a new concrete basement floor slab, 6 mil poly, 2" XPS and continuous bed of gravel.

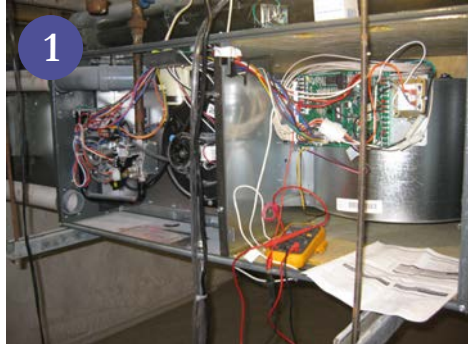
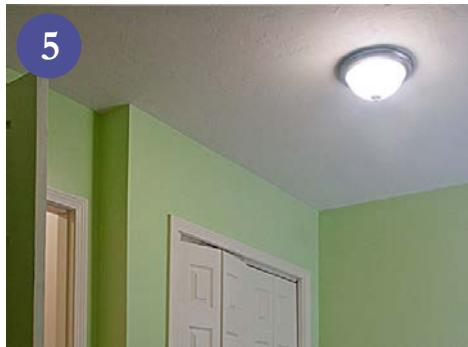
1 Heating: 96% AFUE sealed-combustion gas furnace with a MERV 13 filter. Furnace installed in conditioned space.

3 Space Conditioning Distribution: Air handler and distribution entirely within conditioned space. Sheet metal trunks and run-outs. Ducted return from first floor with transfer grilles above bedroom doors.

4 DHW: 0.82 EF on demand gas water heater

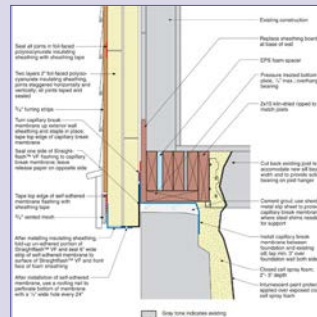
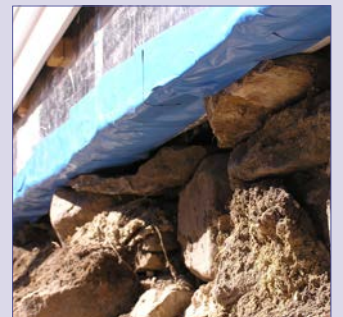
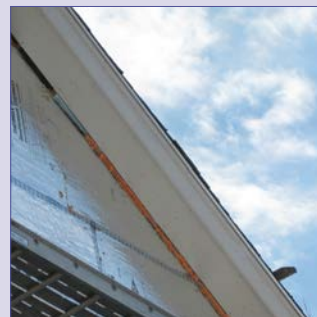
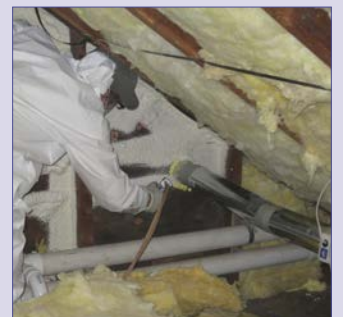
DESIGN CHALLENGE: AIR LEAKAGE CONTROL

Initial plans for this project called for air leakage control of the wall assembly to be accomplished by a carefully detailed housewrap layer applied over the existing sheathing after removal of the existing cladding. During the course of several protracted project delays, this housewrap layer became severely damaged. Rather than remove and re-apply a housewrap air barrier, BSC and HfHGL decided to implement the air barrier at the exterior face of insulating sheathing.

BSC developed details to resolve complex air barrier transitions at the base of the wall, windows, mechanical penetrations, and at roof-wall transitions. Visual inspection as well as blower-door assisted air barrier remediation demonstrated that the air leakage control strategy is highly dependent upon workmanship, project schedule, and timing.

While it certainly is possible to achieve effective air leakage control at the exterior face of insulating sheathing, it is likely that air leakage control systems implemented at the face of existing sheathing will be more readily feasible for retrofit situations.
