Measure Guideline: Wood Window Repair, Rehabilitation, and Replacement

Building America Report - 1203

P. Baker
Building Science Corporation

December 2012

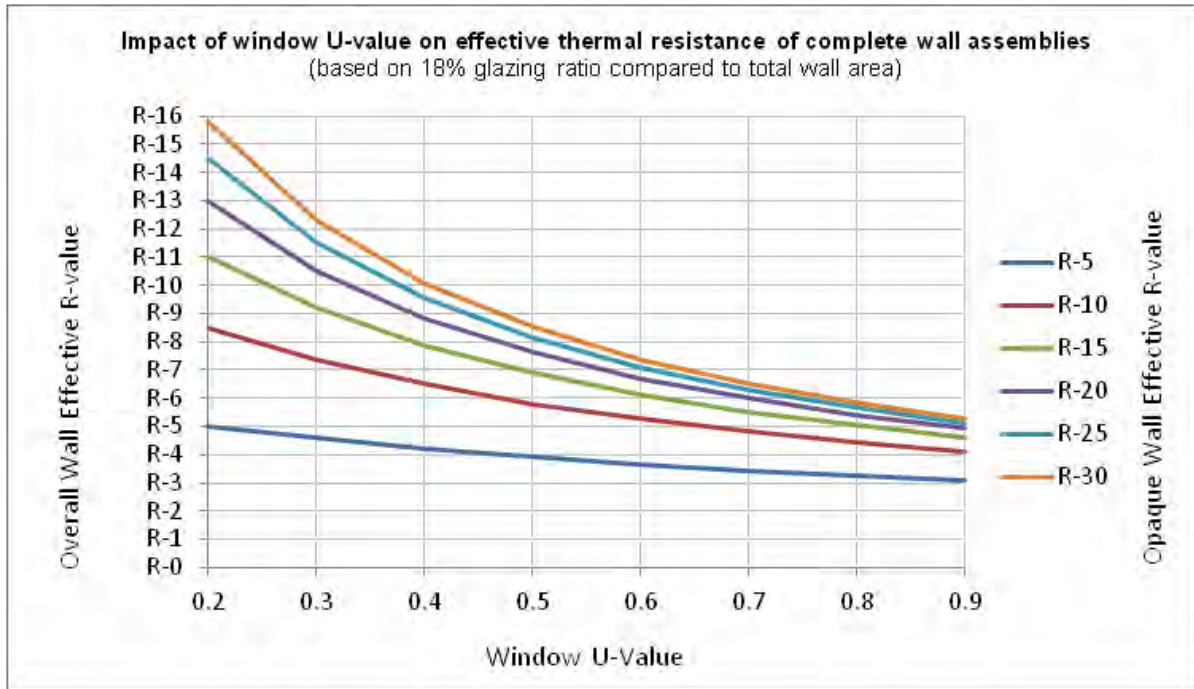
Figure 3. Impact of window U-value on effective thermal resistance of complete wall assemblies

Old single-glazed windows have such low thermal resistance that their effect on the overall thermal resistance of the walls can be staggering. A simple UA¹ analysis that compares the total wall effective R-value to the window U-value for opaque wall assemblies of varying effective R-values shows how significant this impact can be (Figure 3).

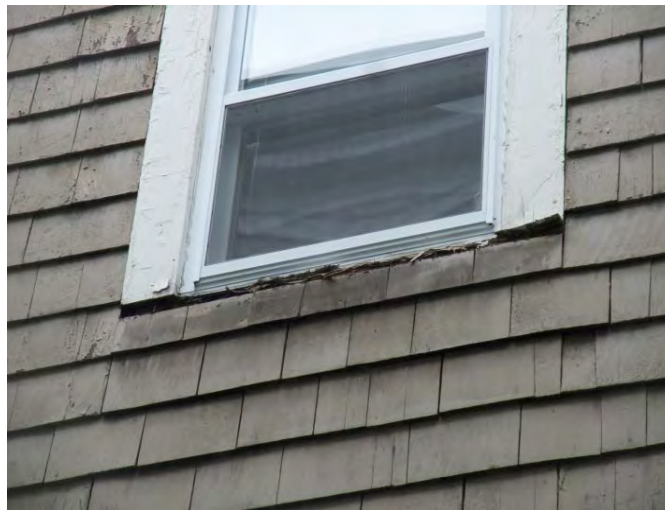
Figure 5. Failed window sill with replacement window installed

The window sill is arguably the most important element of the window assembly, as water will drain downward by gravity either into the wall (e.g., hole through sill) or directly onto the wall (failure of the sill extension). For all proposed measures in this guideline (except complete window replacement), the condition of the sill is critical to the performance of the measure. Cracked or rotting sills need to be replaced before any work is done (see Figure 5).

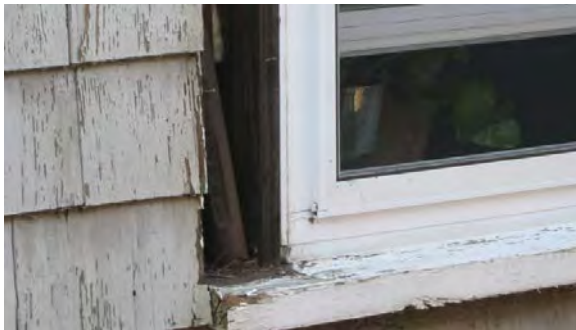
Figure 17. Sash weight pockets

The largest of the voids are typically at the weight pockets created to house the sash counterweights (see Figure 17 and Figure 18). The weights are connected to the sashes through either ropes or chains that run from the sash to a pulley near the top of the window jamb and into the weight pocket. When combined with an interior storm window (both temporary and permanent), the pulley weight pockets can create a condensation potential (discussed in Section 3.1.3), as they are a pathway for movement of interior air into the space between the old window and the new interior glazing element. Often, the sash weights can be eliminated by retrofitting the windows a spring-loaded tape balance. Abandoned weight pockets permit energy loss from conductance and from uncontrolled air leakage. Even when they are insulated, it is often done in a “blind” manner (inserting insulation through an access hole in the jamb), resulting in poor installation quality.

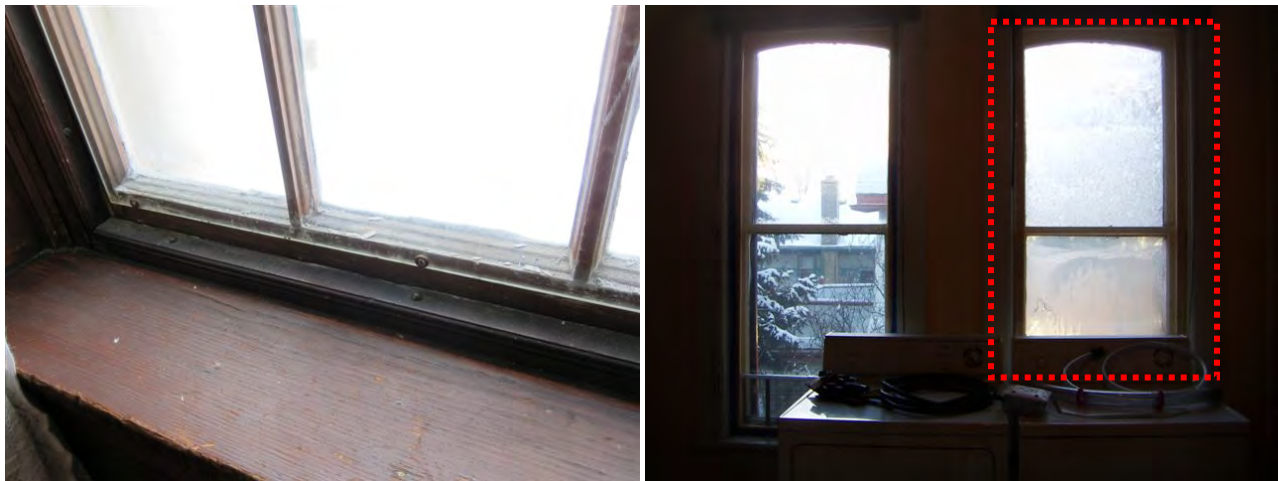
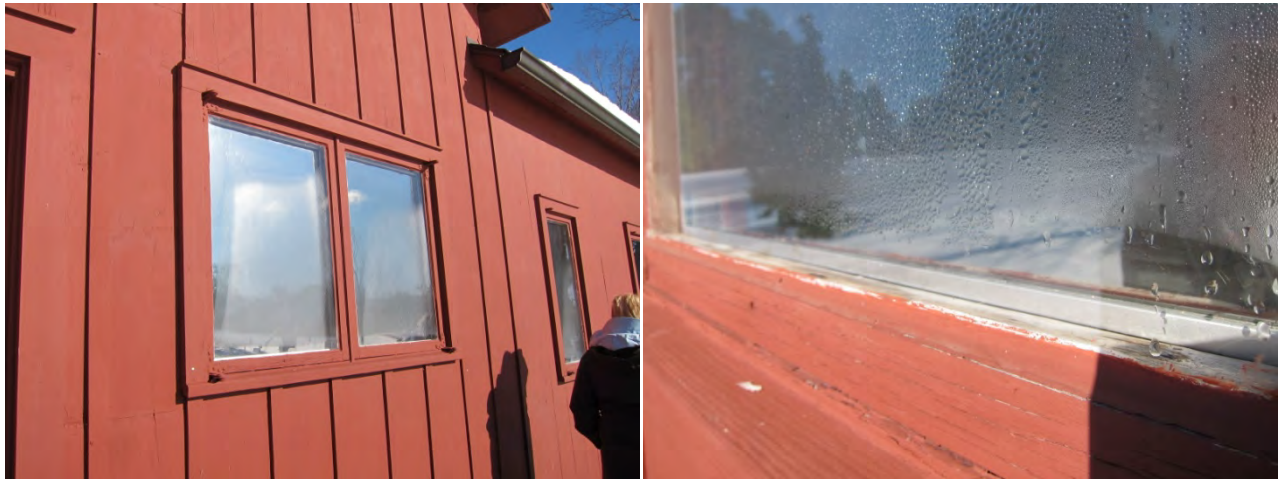
Figure 19. Examples of condensation problems with interior storm window retrofits

Figure 20. Examples of condensation problems with interior storm window retrofits

The addition of interior or exterior glazing elements to the original window creates a potential for the formation of condensation between the two glazing elements. The placement of the interior or exterior of the window creates an insulating air pocket, resulting in the outer glazing element to be at a lower temperature at wintertime conditions. This increases the chance of condensation forming, if interior moisture laden air can infiltrate the space.

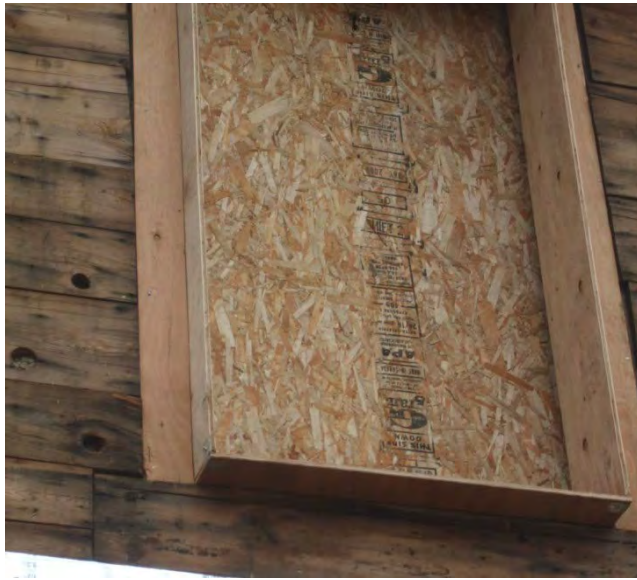
Figure 34. New window rough opening framed with and extension box to allow for the addition of exterior insulation

Ultimately the old window can be completely removed and replaced with a new window. The benefit of this measure is that the installation details can be brought up to current installation standards. This approach is typically most common with more extensive building retrofits, as it generally requires disturbance to both interior as well as exterior finishes. When combined with a more extensive energy retrofit that includes the addition of exterior insulation, it provides the most freedom for designing and placing the windows. The windows can be installed in plane with the framing or be pushed toward the exterior to line up more traditionally with the plane of the siding.

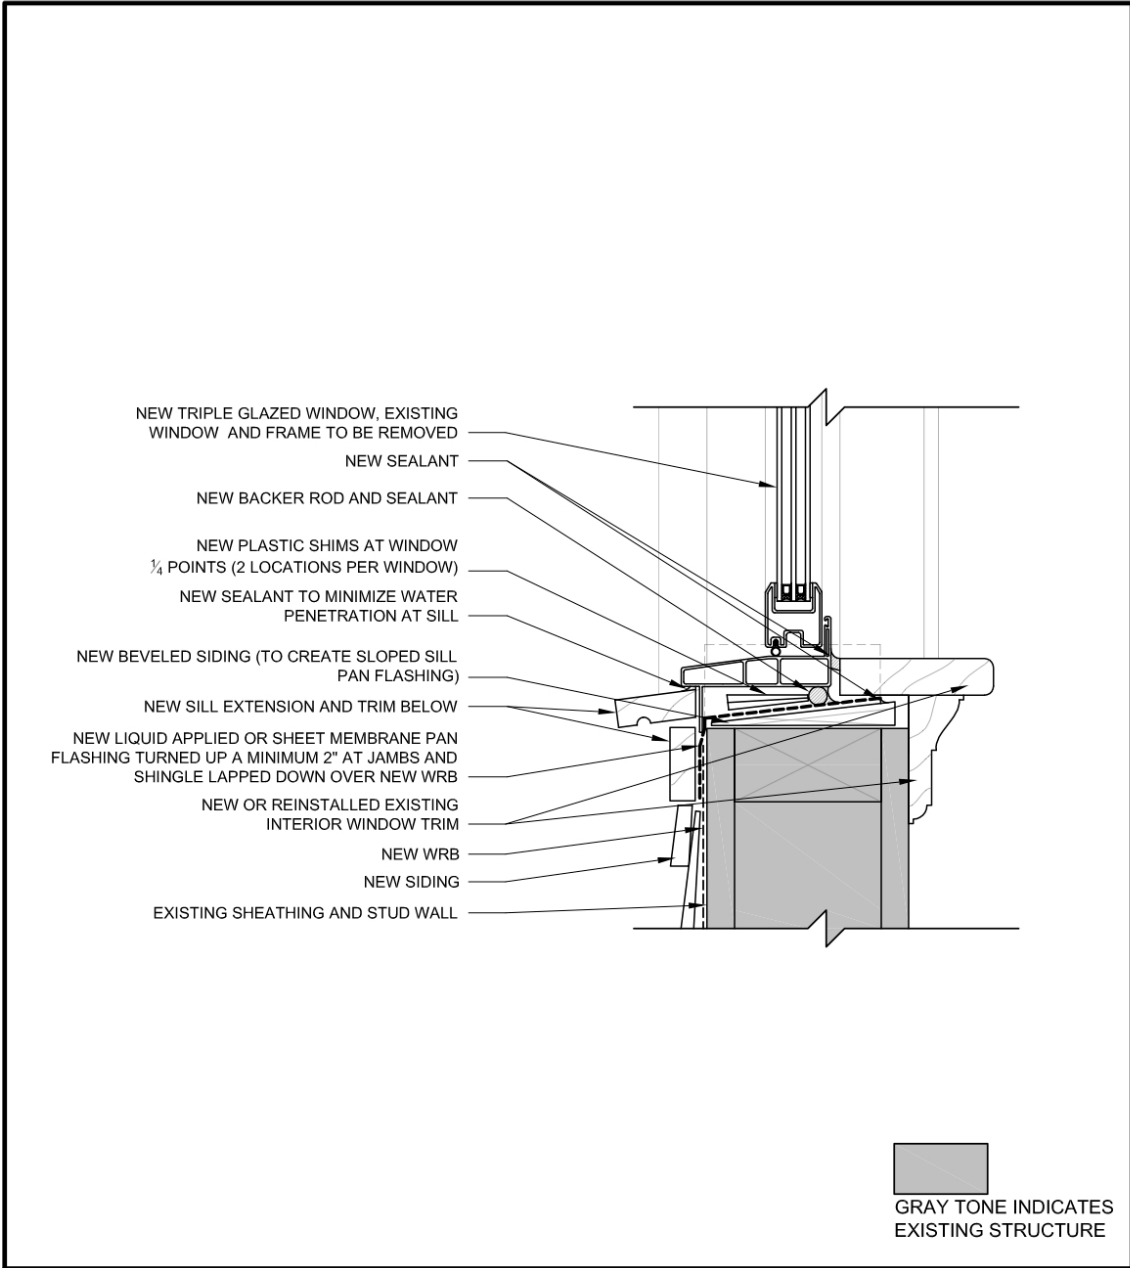
M8-B: COMPLETE REPLACEMENT WINDOW - SILL DETAIL
