National Grid Deep Energy Retrofit Pilot

Building America Report - 1111

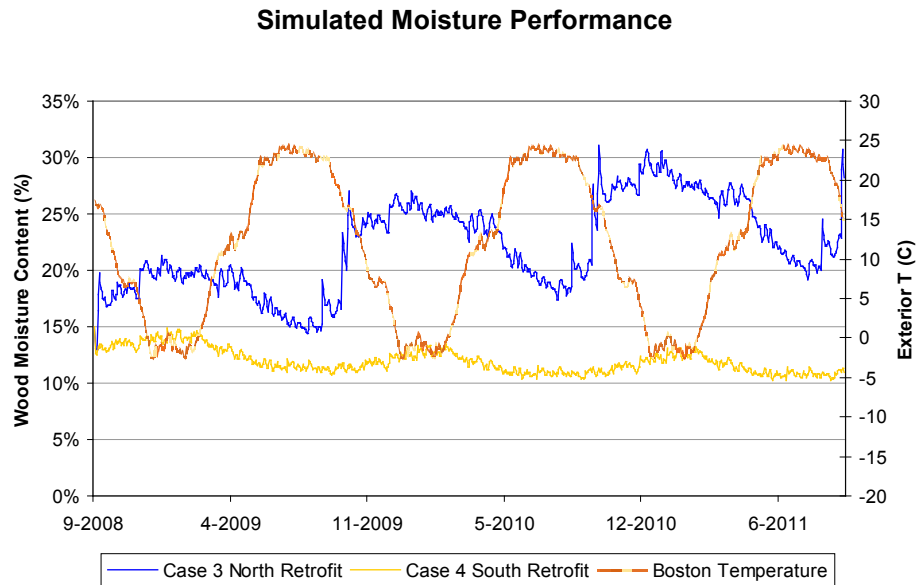
Figure 2. Retrofitted wall with 0.5% of incident rain penetration, north and south exposures, with exterior temperature for reference (seasonal patterns)
(Ueno 2010)

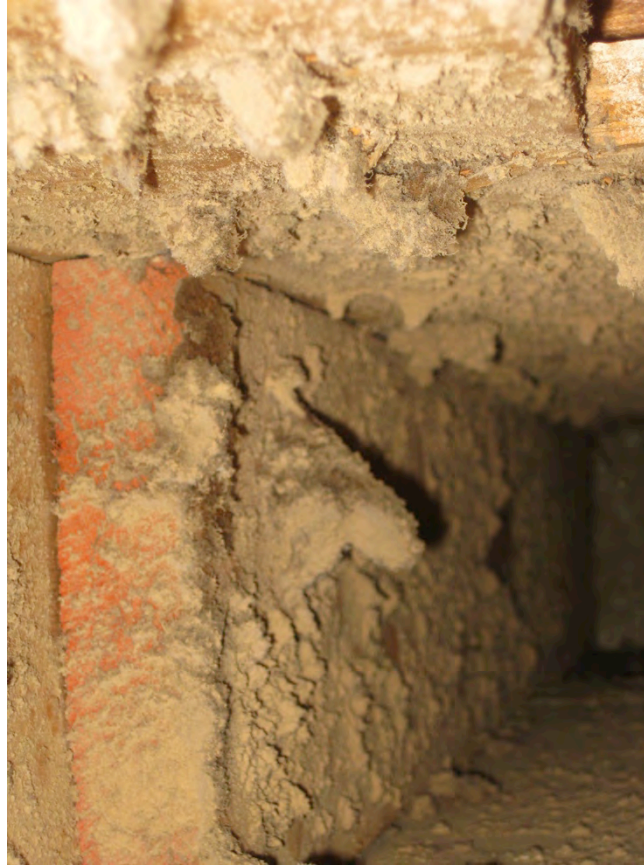
Figure 4. View inside framing cavity forced-air duct return at Test Home 1

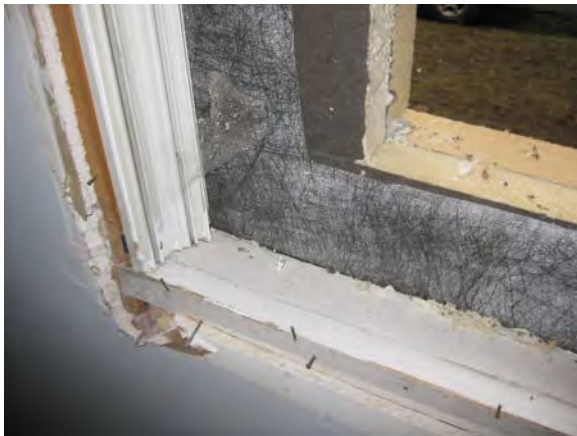
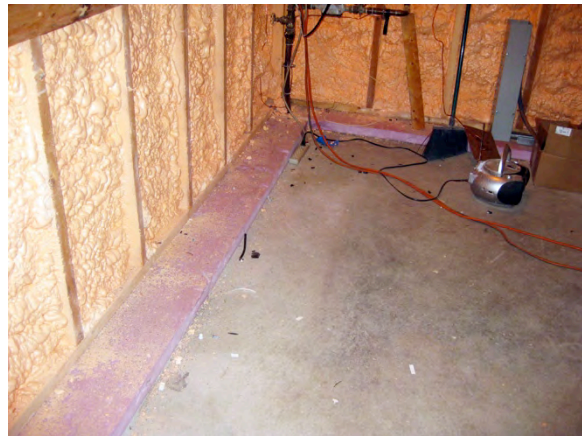
Figure 7. Left: Window opening at Test Home 1 with existing window still in place. Note exterior insulation and house wrap airflow control layers installed to exterior; Right: Basement slab perimeter insulation at Test Home 1.

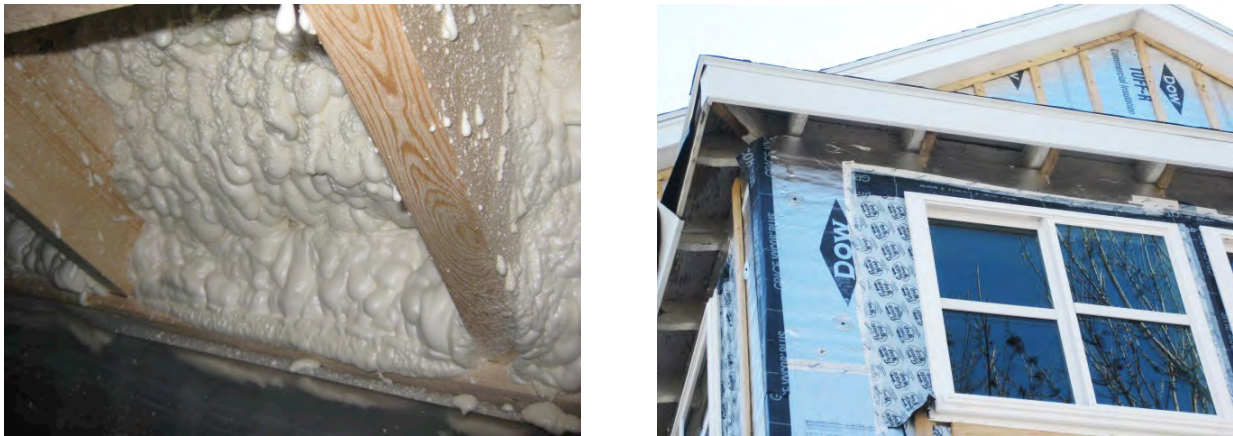
Figure 14. Left: ccSPF providing transition of airflow control at new roof to new wall transition; Right: Rigid exterior insulation notched around projecting rafters.

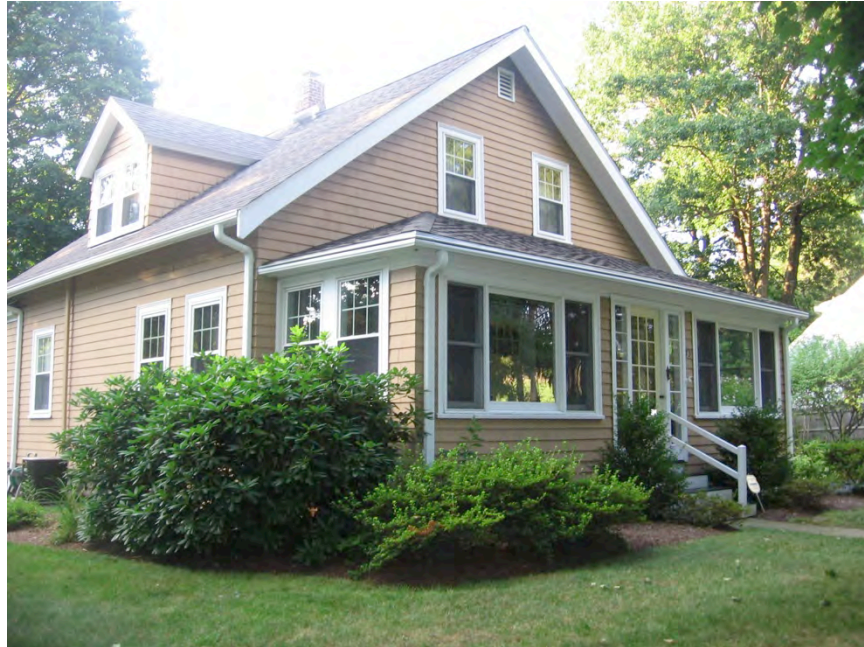
Figure 15. Pre-retrofit Cape located in Newton, Massachusetts
(Credit: Vahe Ohanesian/V.O. Design-Build, Inc., used with permission)

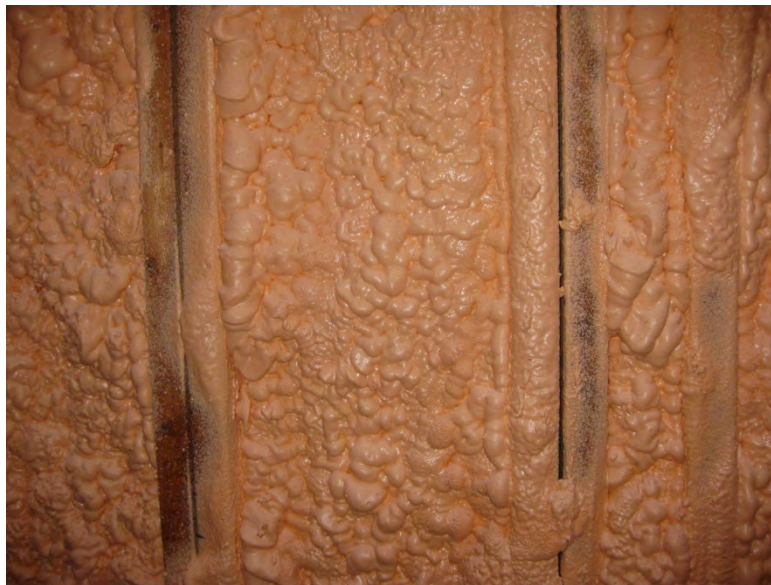
Figure 21. Airflow channels between double roof rafters at Test Home 1

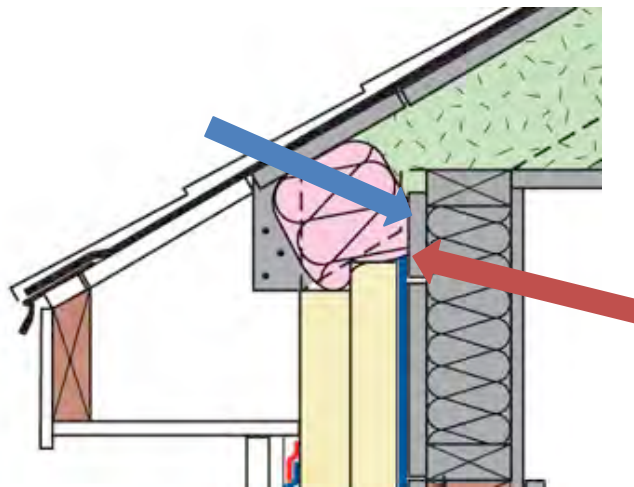
Figure 23. Airflow channels between double roof rafters at Test Home 1

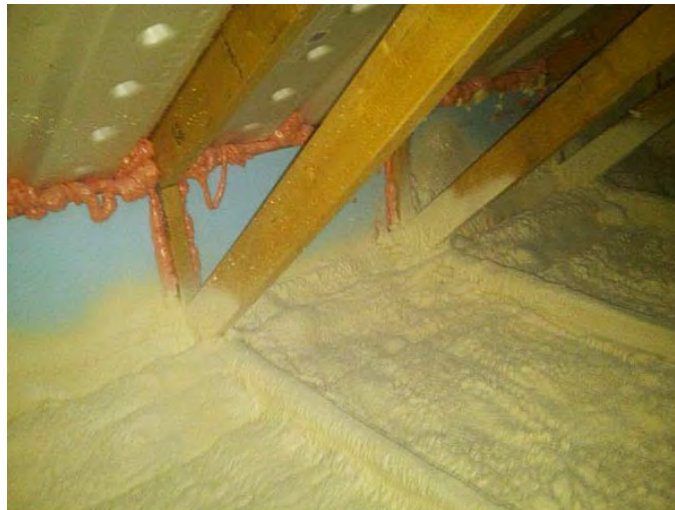
Figure 29. ccSPF airflow control layer in vented attic at Test Home 5

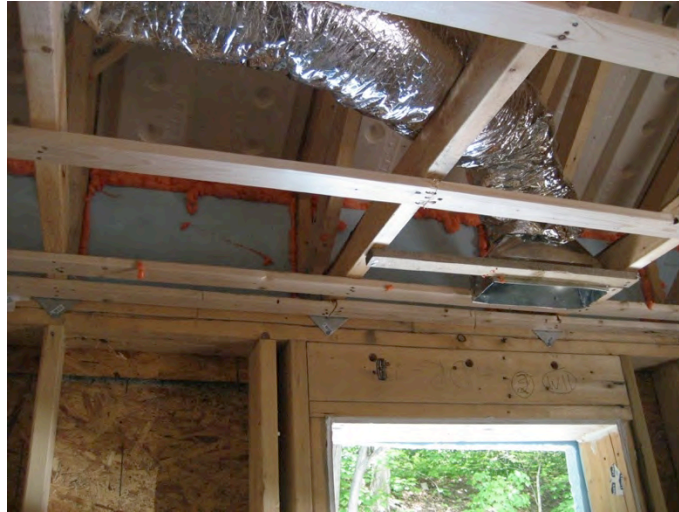
Figure 30. Ventilation duct initially located above airflow control layer in vented attic at Test Home 5

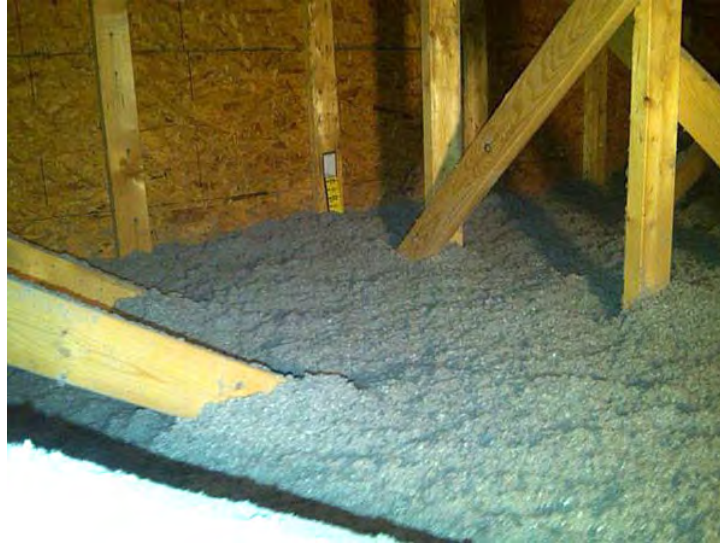
Figure 33. Loose-blown insulation in vented attic at Test Home 5

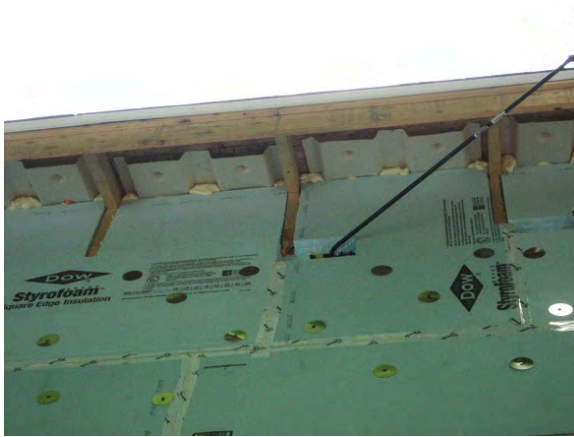
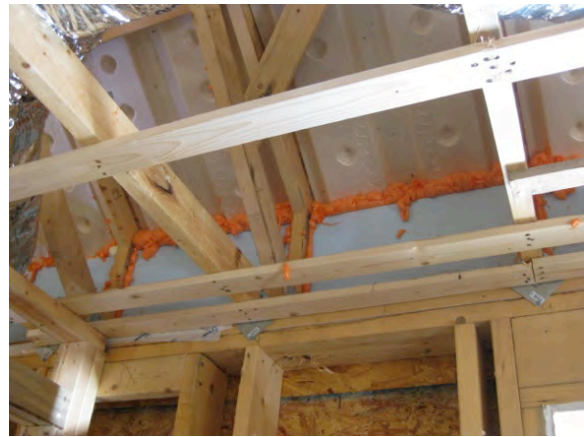
Figure 34: Left: Rigid insulation blocking between roof trusses at Test Home 5 exterior; Right: Rigid insulation blocking between roof trusses at Test Home 5 interior

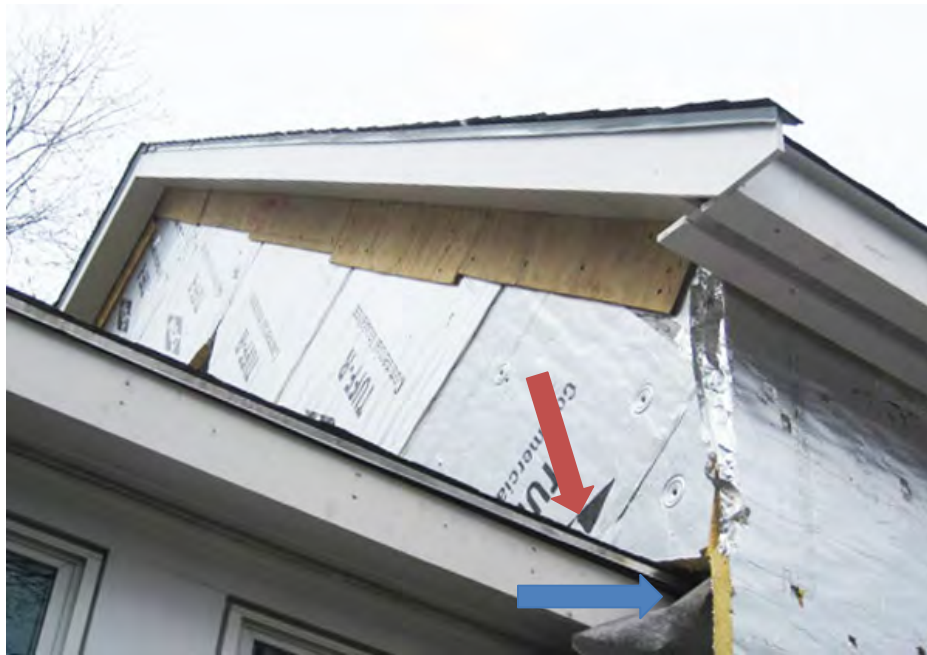
Figure 35. Wall-roof interface at Test Home 4 showing two common flashing errors: 1) step flashing is not located at plane of water control, and 2) drip edge of lower roof creates a condition where water may be directed in behind the drainage plane. Note that both of these conditions were corrected at this test home.

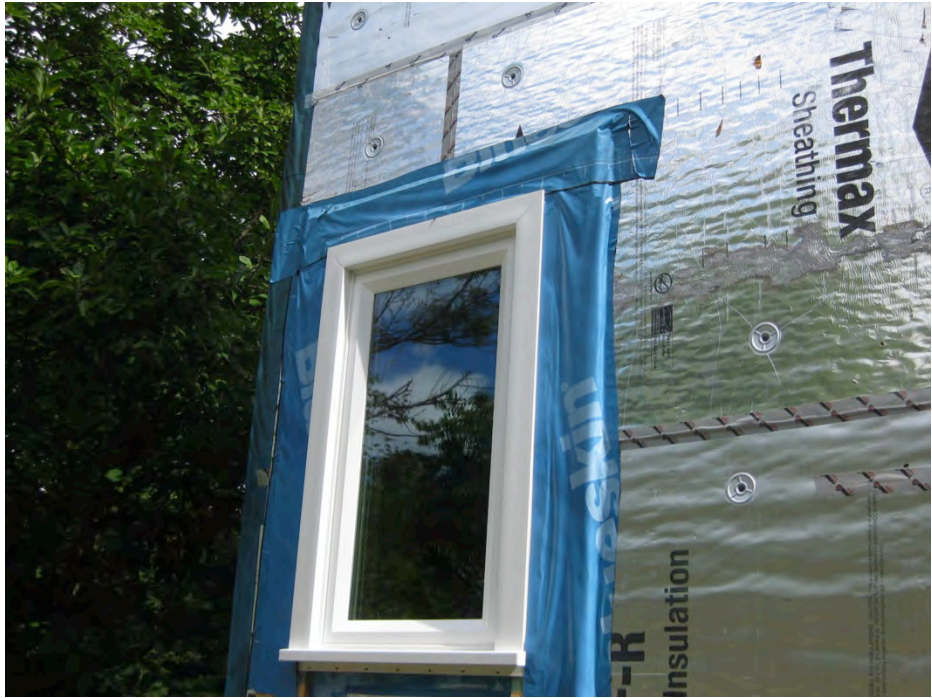
Figure 36. Nonterminated flashing membrane presents risk of collecting water

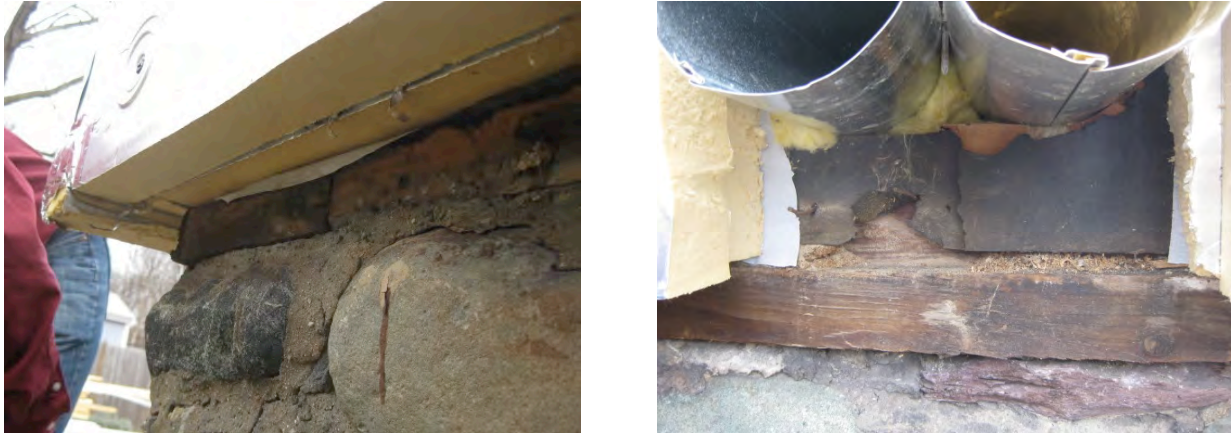
Figure 38. Left: Exterior insulation installed prior to sealing house wrap to base of wall for airflow control transition; Right: Portions of exterior insulation must be removed to allow air sealing of the house wrap at these pipe penetrations.

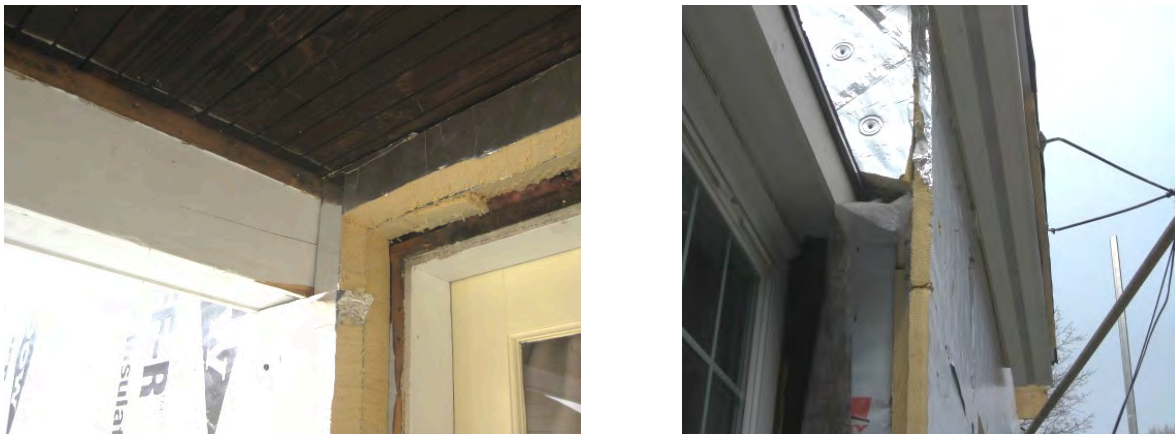
Figure 39. Left: Porch roof support beam with trim and porch ceiling void airflow control where they connect to the wall and penetrate exterior insulation; Right: A porch roof return that connects to the existing wall challenges continuity of airflow control.

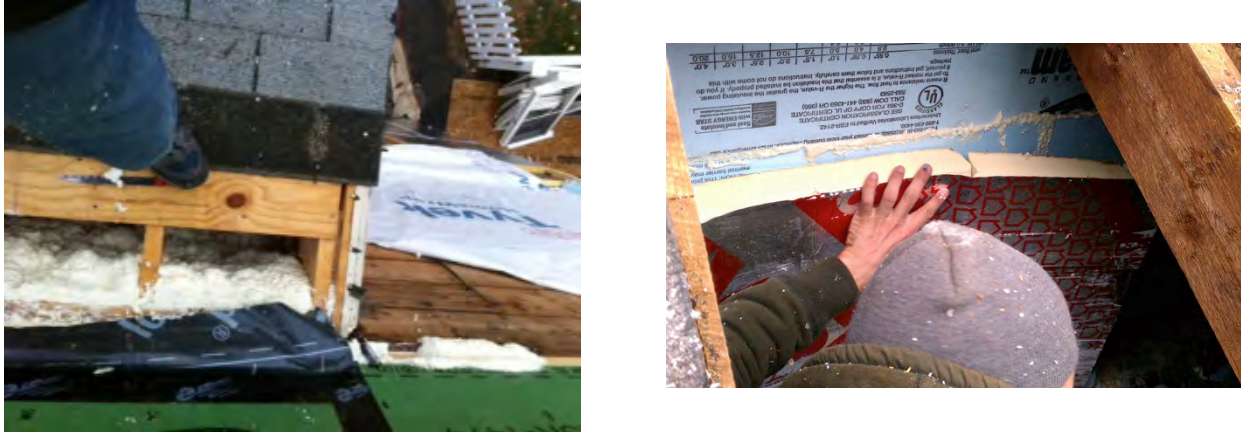
Figure 40. Left: ccSPF airflow control around porch roof framing at Test Home 3; Right: Worker applying rigid foam and foam sealant between attached porch roof and porch ceiling, Test Home 4

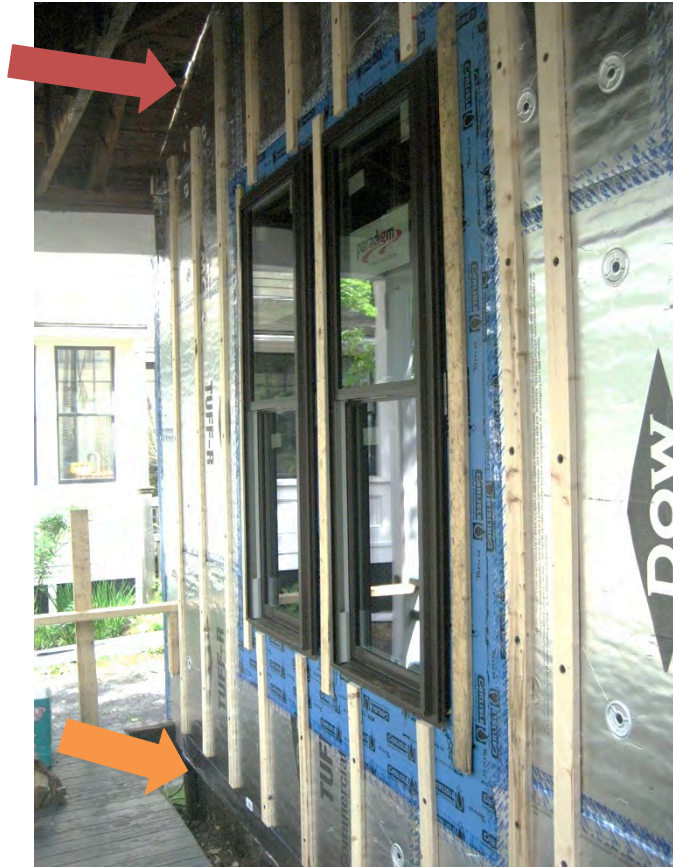
Figure 41. Porch deck, ceiling, and roof cut away from wall to allow continuous air, thermal, and water control, Test Home 2

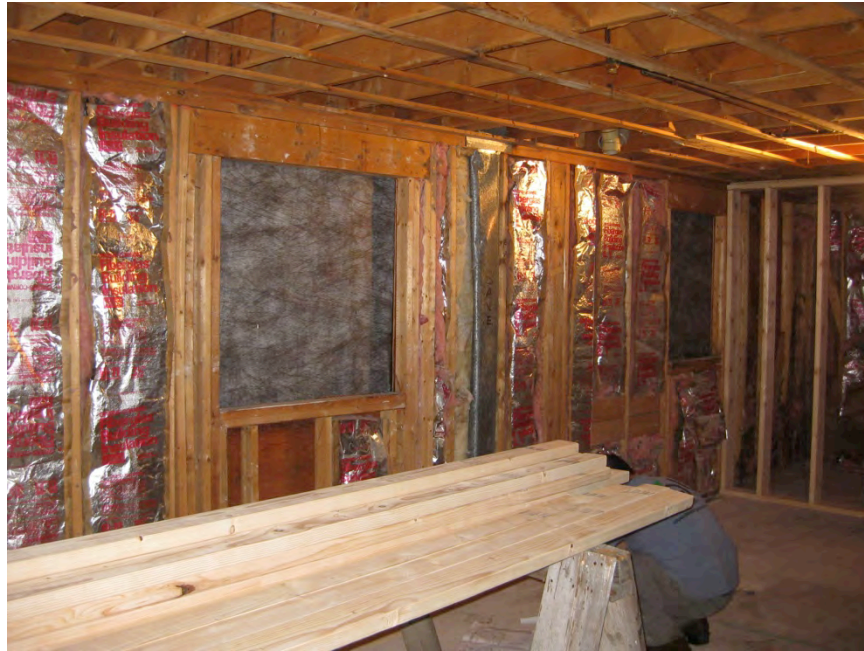
Figure 42. Foil-faced cavity insulation representing a second vapor retarder, Test Home 1

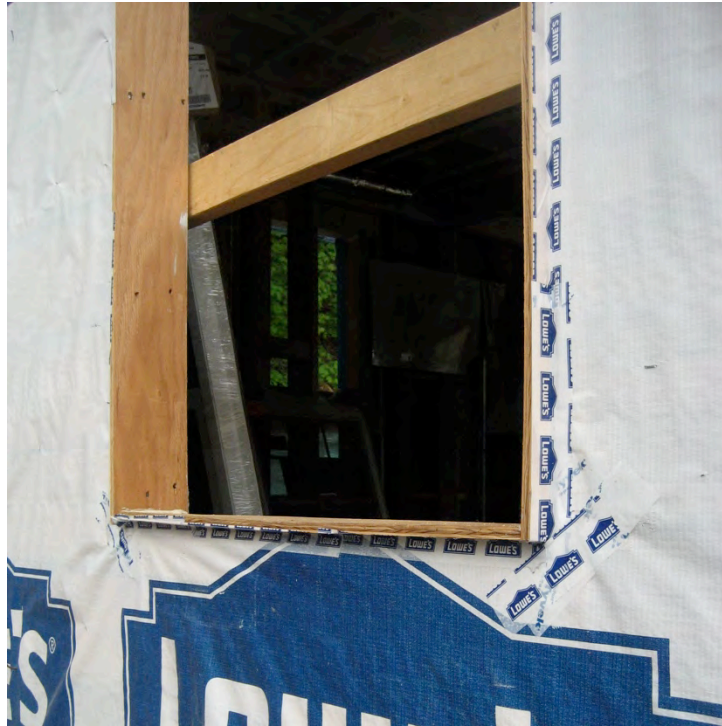
Figure 43. House wrap airflow control layer sealed to window extension box at Test Home 5

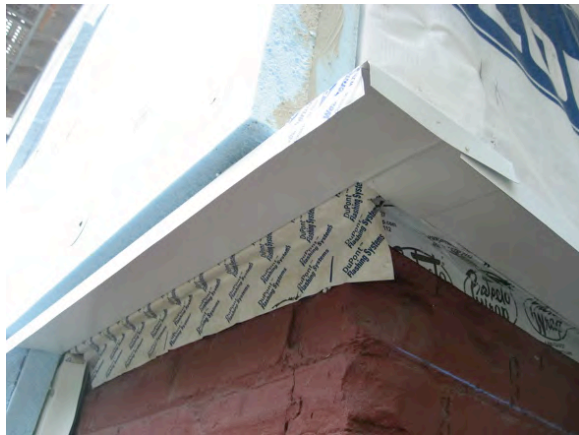
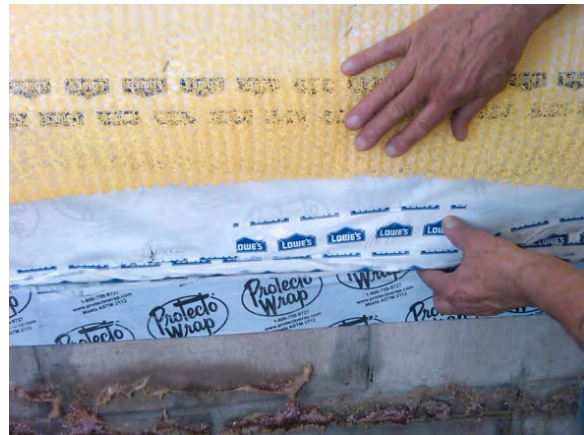
Figure 44. Left: Airflow control transition at existing brick foundation wall, Test Home 5; Right: Airflow control transition at new CMU foundation wall section, Test Home 5

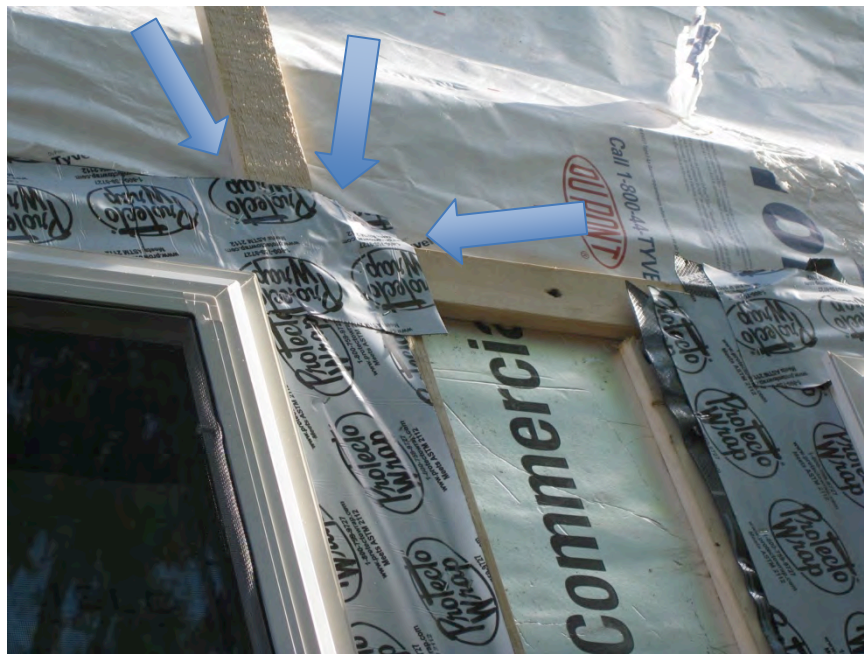
Figure 48. Scoop flashing at head of window installed over strapping at Test Home 3. Arrows indicate where water would be able to pass behind the flashing.

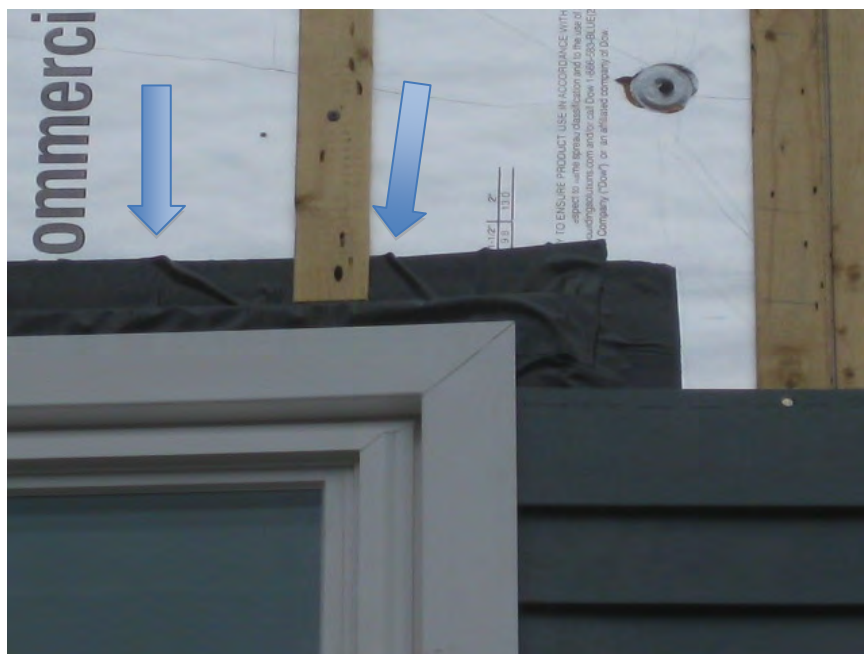
Figure 49. Wrinkles in flashing membrane wrapped over strapping and back to drainage plane. Note how this window head flashing requires flashing of its own.

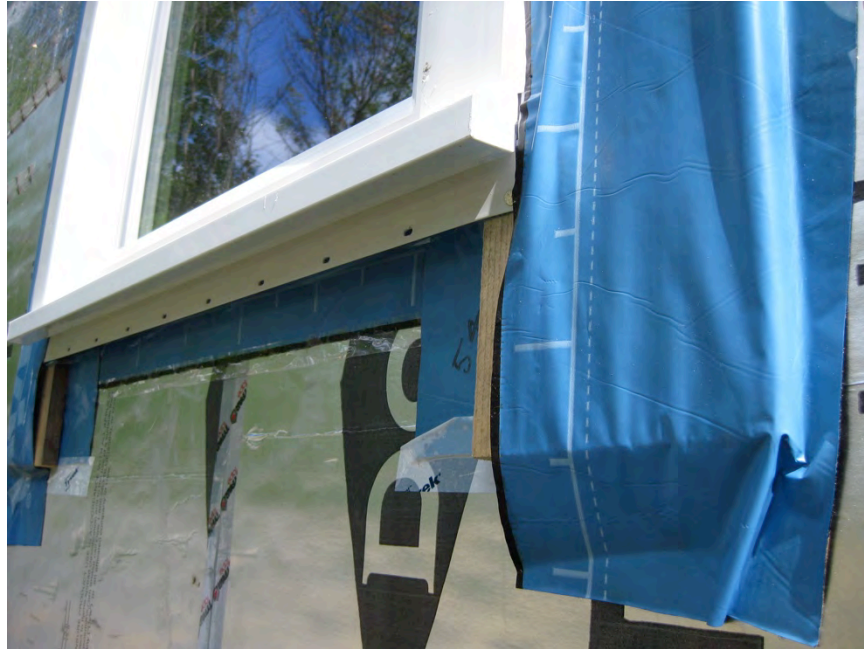
Figure 50. Installation of the window over strapping provides a generous drainage gap for the sill pan flashing.

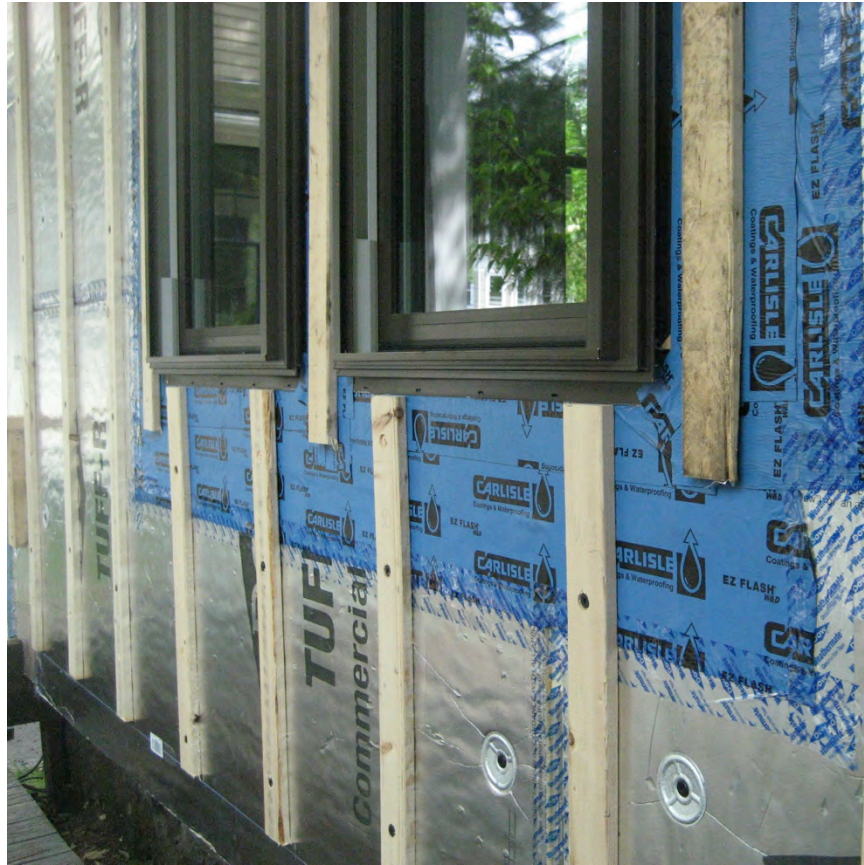
Figure 51. Window installed with flanges aligned with drainage plane at Test Home 2. Note strapping run up to, but not over, bottom flange of window. A single piece of strapping at the side of the window is sufficient to support both trim and cladding attachment.

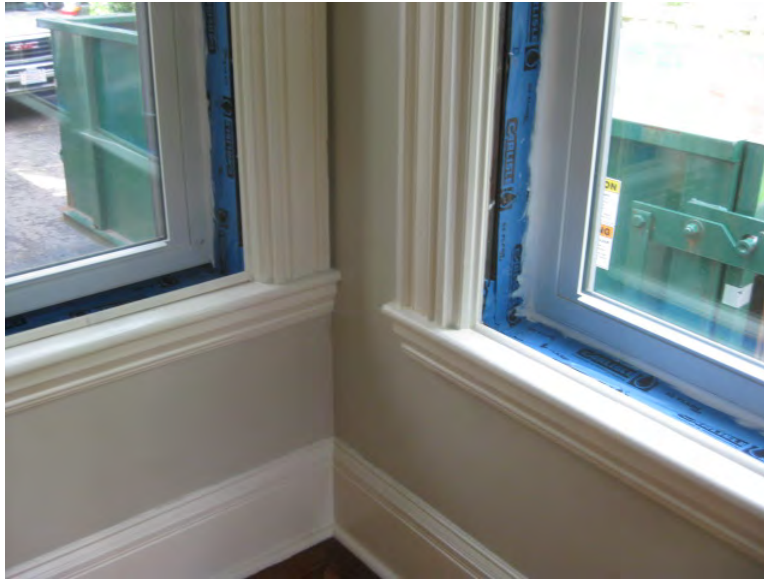
Figure 52. Window sealed to membrane at inside perimeter of window at Test Home 2. Note how the window frame is slightly larger than the finished opening.

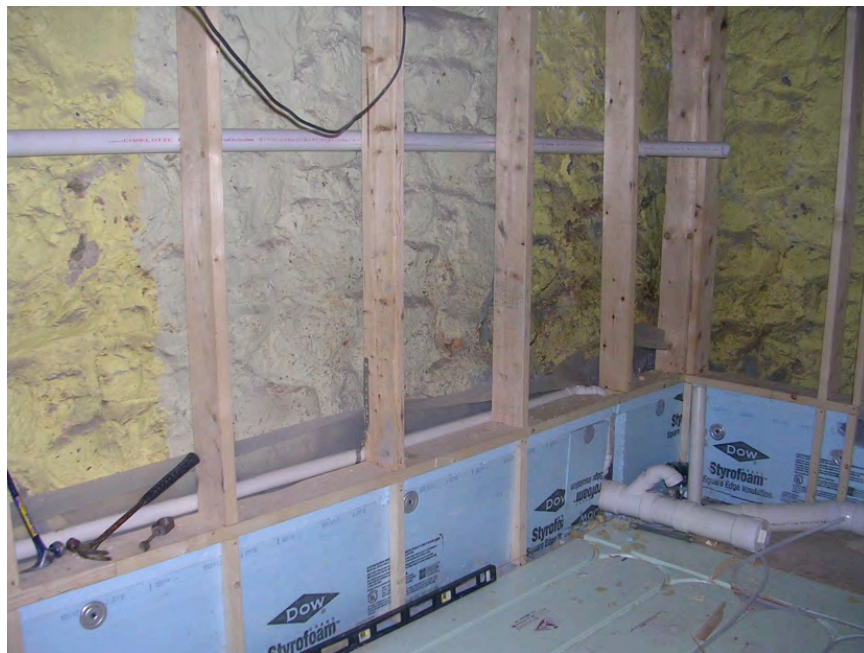
Figure 53. Thermal break between wood stud wall and concrete underpinning wall at Test Home 4

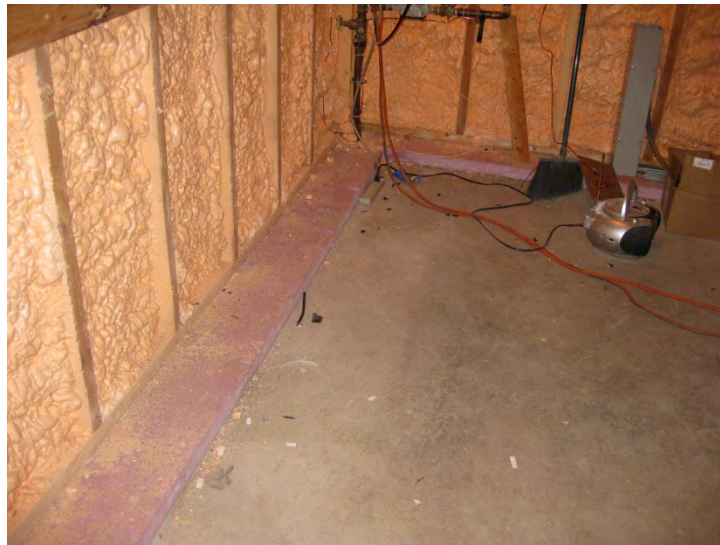
Figure 54. Thermal break between wood stud wall and existing concrete slab at Test Home 1

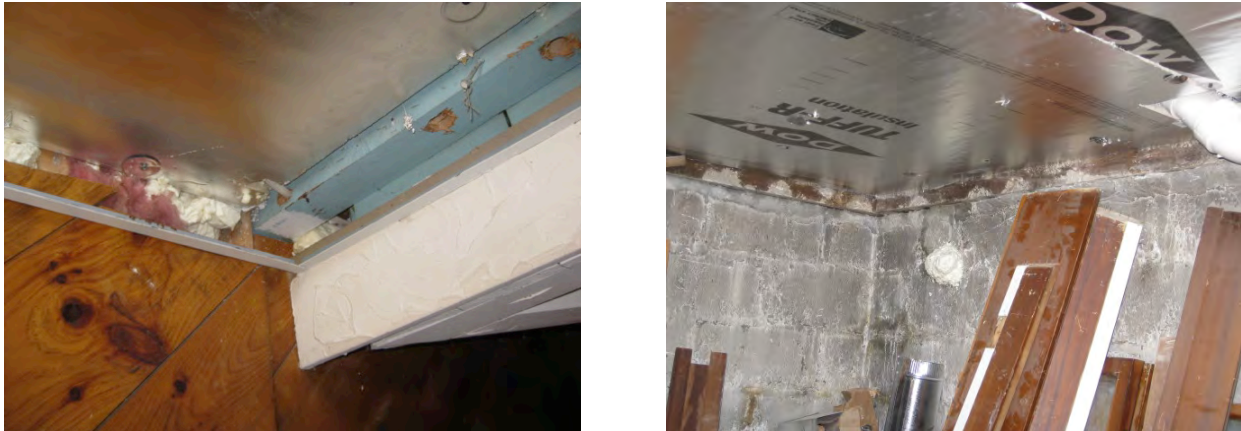
Figure 55. Left: Structural beam exposed to basement; Right: Framed wall sill exposed to basement

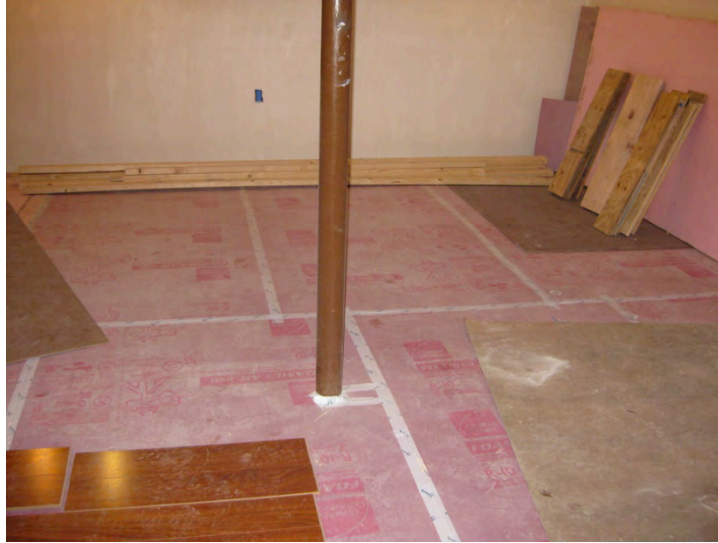
Figure 56. Basement floor insulation at Test Home 1 installed near end of project to prevent damage to insulation

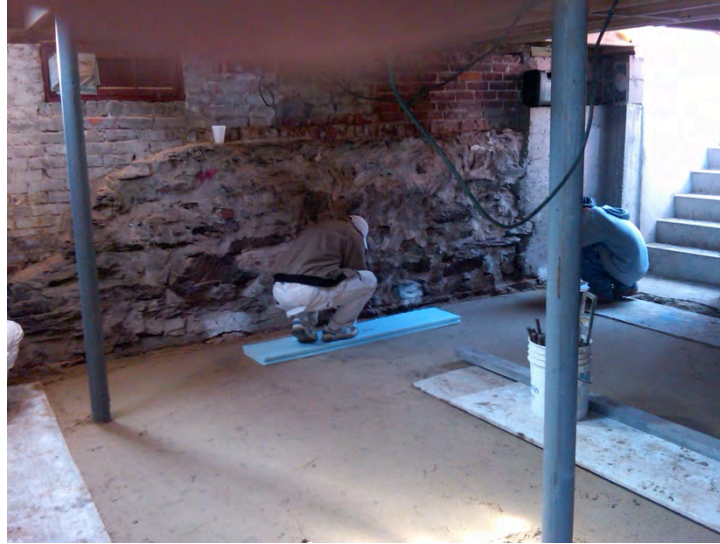
Figure 57. New basement slab and structural support at Test Home 5

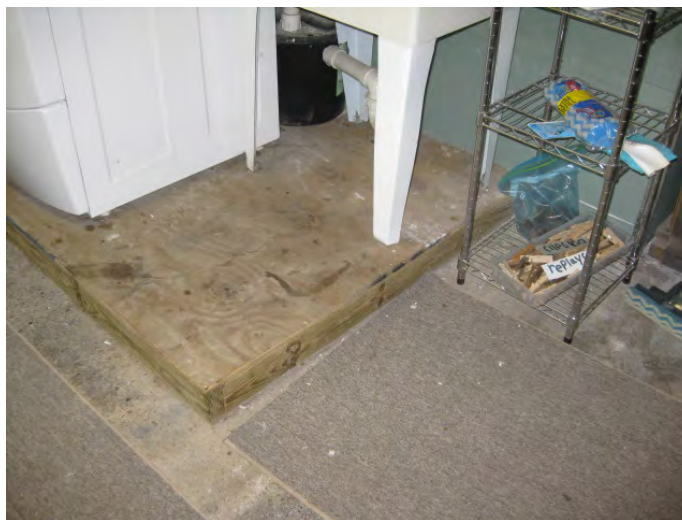
Figure 58. Equipment platform and shelving in basement of Test Home 2

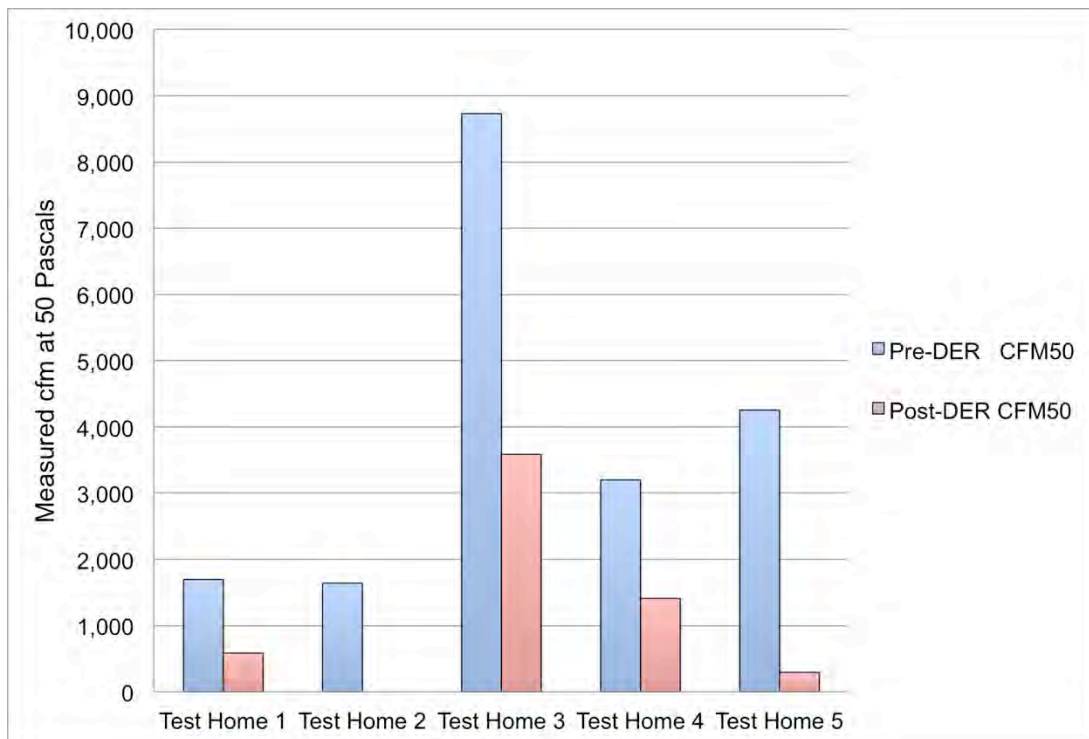
Figure 59. Pre- and post-retrofit CFM50 measurements

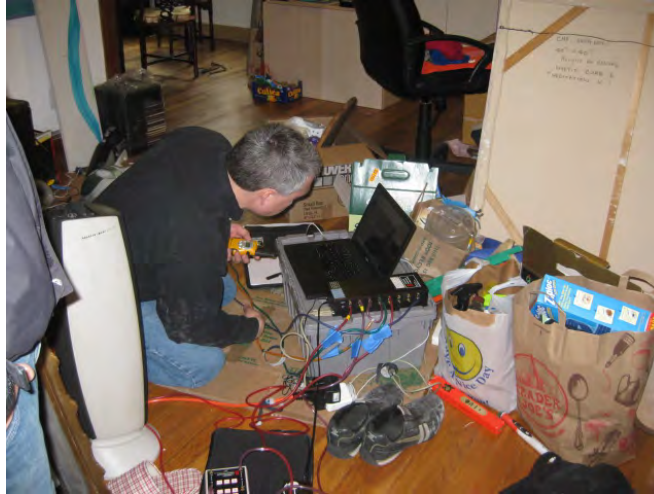
Figure 61. Post-DER guarded blower door testing at Test Home 3

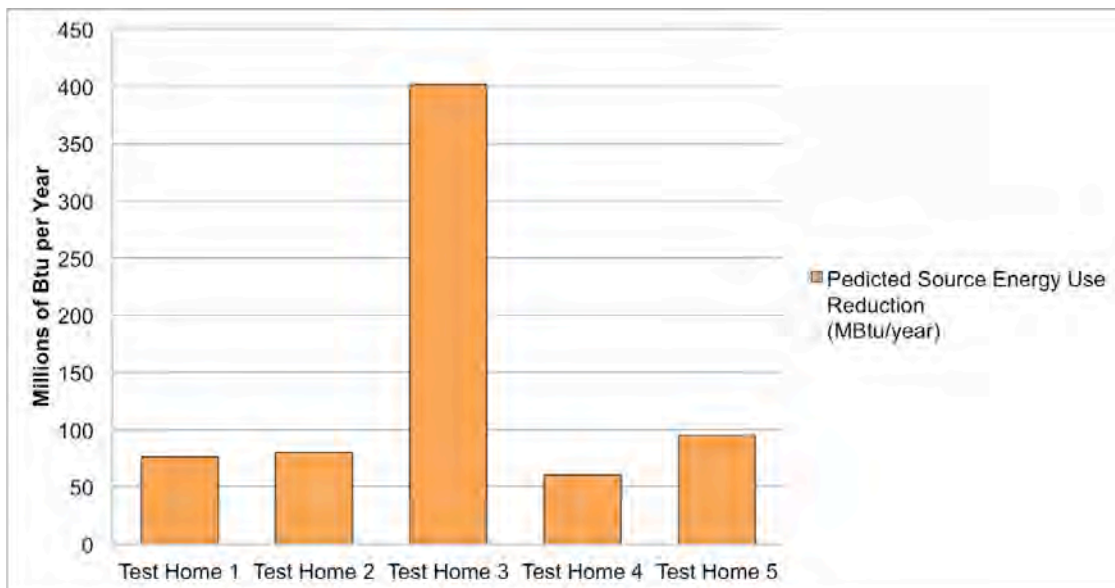
Figure 62. Predicted annual source energy use reduction relative to pre-retrofit condition

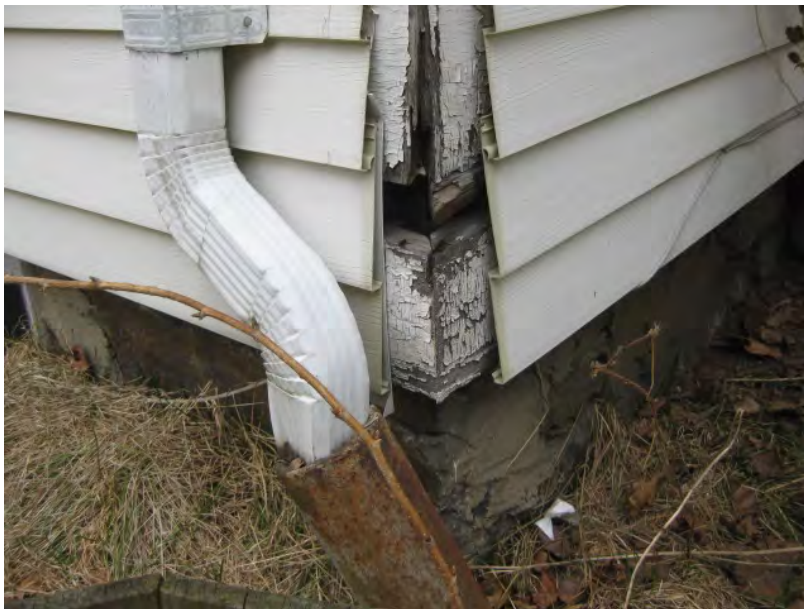
Figure 65. Vinyl siding and deteriorated wood cladding at Test Home 2

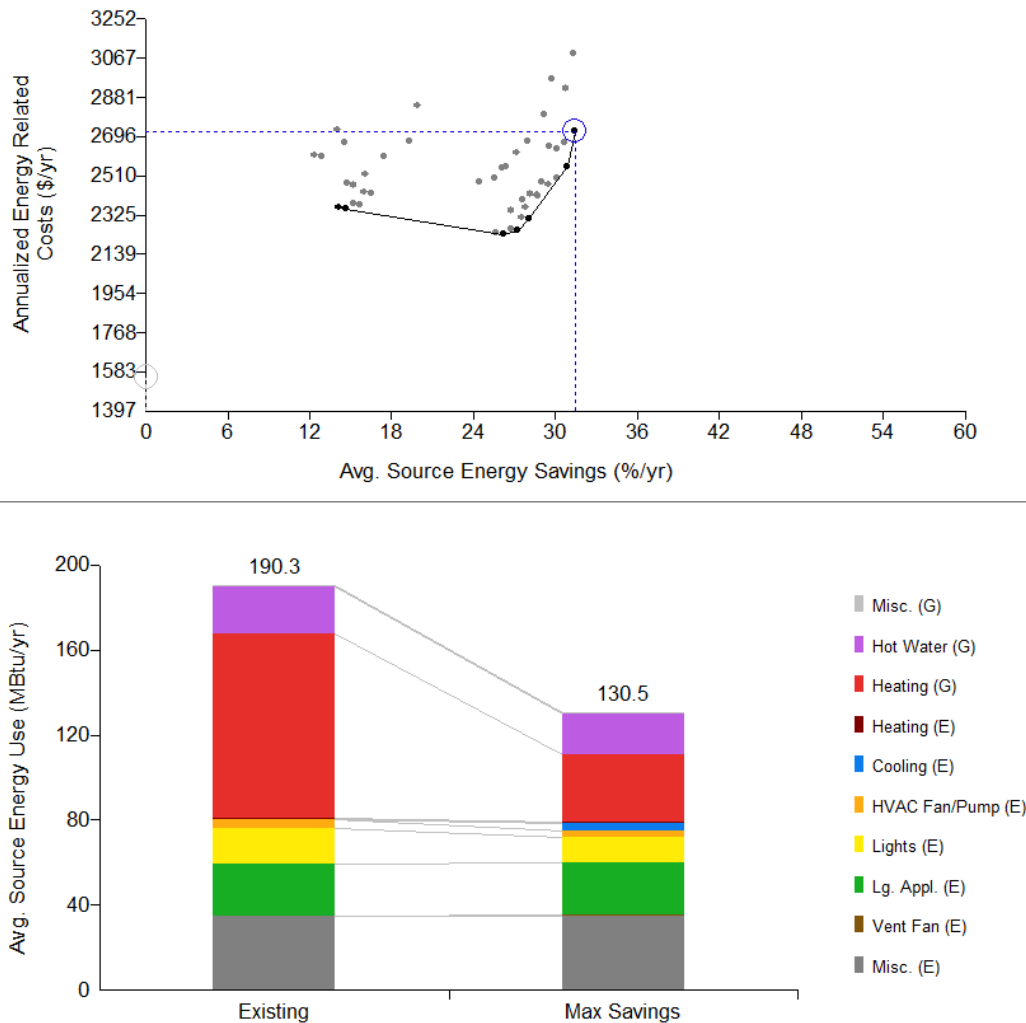
Figure 68. Test Home 4 BEopt results for as-built condition and alternatives

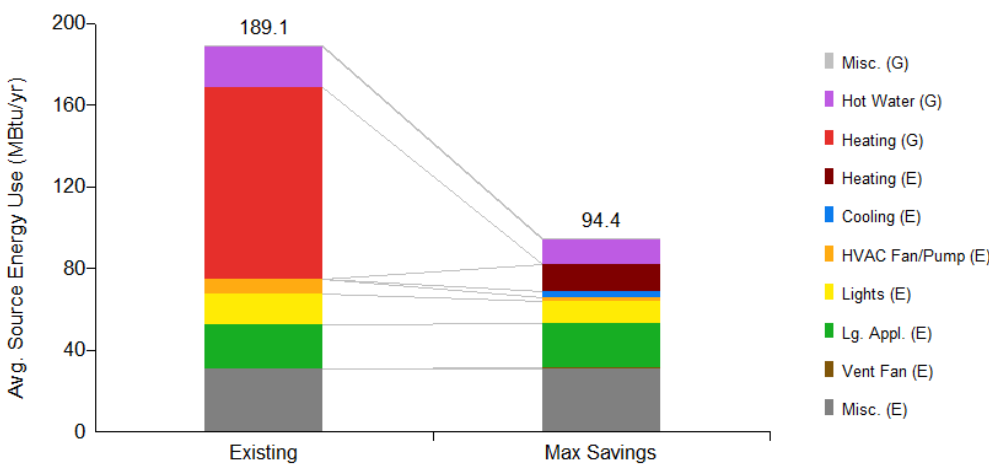
Figure 69. Test Home 5 BEopt results for as-built condition and alternatives

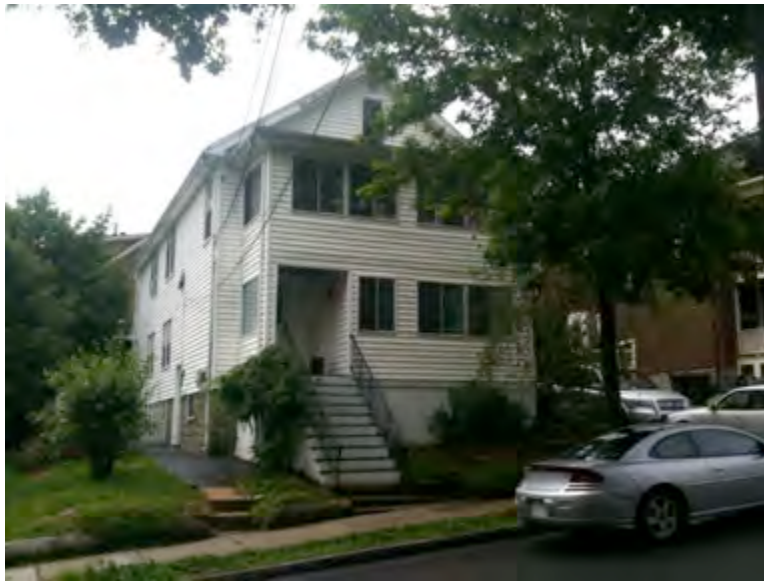
I find it curious that the project would insulate to the interior with closed cell spray foam when the application indicates that the roof is to be replaced. The depth of foam that would be required to meet the target R-value would represent a significant material cost per unit area, probably somewhere in the range of \$3.75-7/s.f. To reach a comparable R-value with polyisocyanurate above the roof and fiberglass batt insulation within the roof framing cavities would entail a material cost in the neighborhood of \$3.60/s.f. (including ½ plywood for nailbase and 6" screws). It will be interesting to learn from the builder about the labor costs and how these affect the relative costs of different roof insulation strategies.

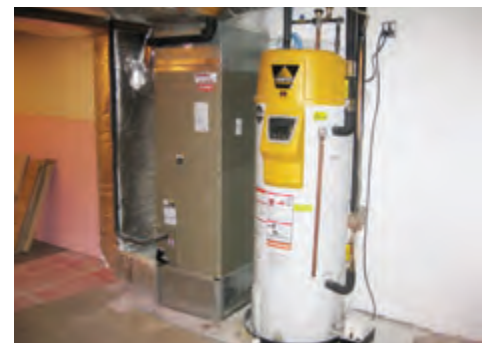
The mechanical system plan included forced-air heating and cooling distribution and balanced ventilation. The equipment selection for this system as well as the water heating system and configuration of the attic/roof insulation were dictated by the availability of donated products.

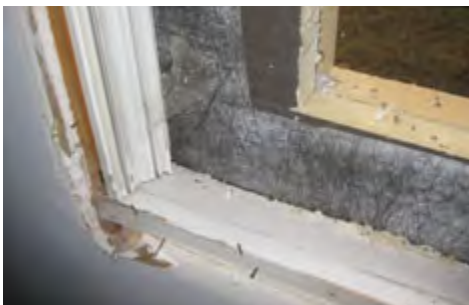
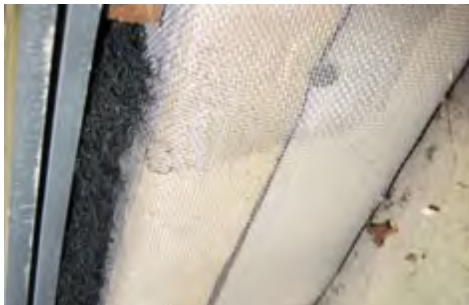
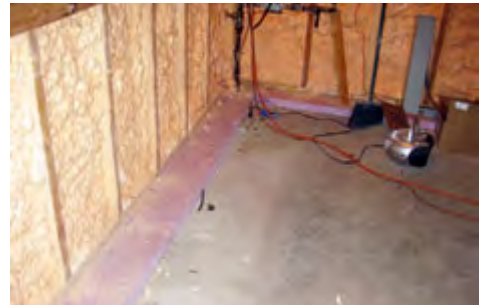
TESTING AND ON-SITE TECHNICAL SUPPORT

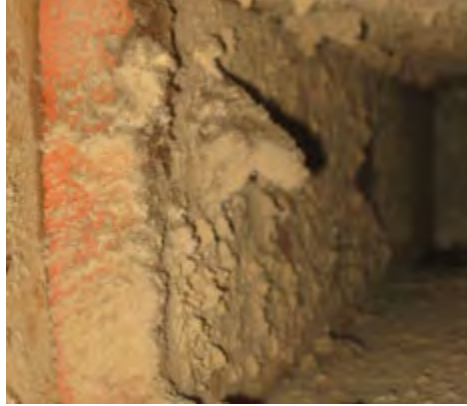
age at 1695 cfm at 50 Pascals or near 4 ACH50. BSC measured the post-retrofit air leakage to be 584 cfm50 or 1.6 ACH50.

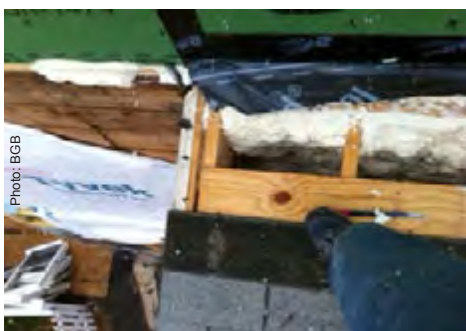
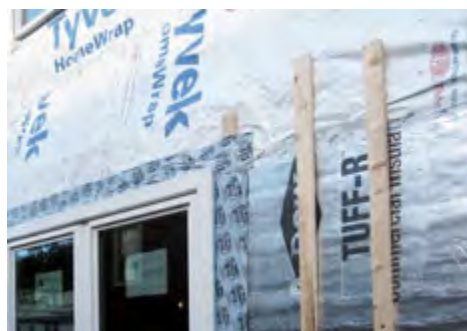
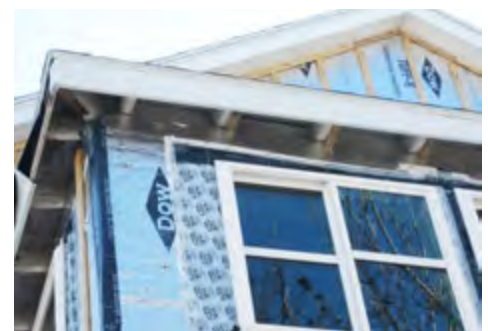
TESTING AND ON-SITE TECHNICAL SUPPORT

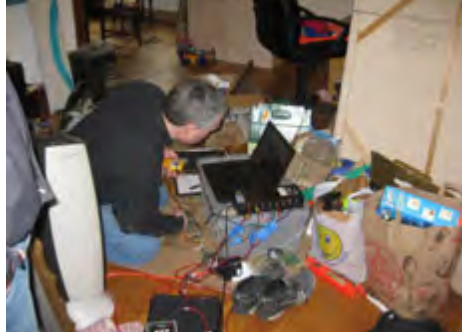
The pre-retrofit fully unguarded test of the apartment space found it to be rather air leaky at 8730 cfm50 or 26 ACH50. Comparison to guarded testing of the apartment space and basement suggests that about 45% of the combined apartment leakage is at the basement-apartment separation. After substantial completion of the retrofit
