National Grid Deep Energy Retrofit Pilot

Building America Report - 1111

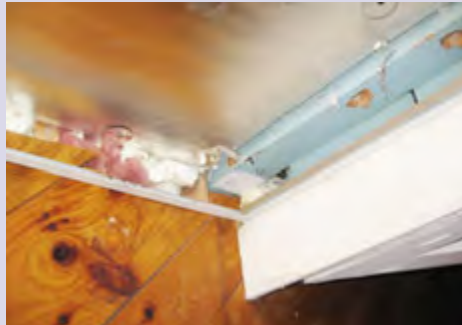
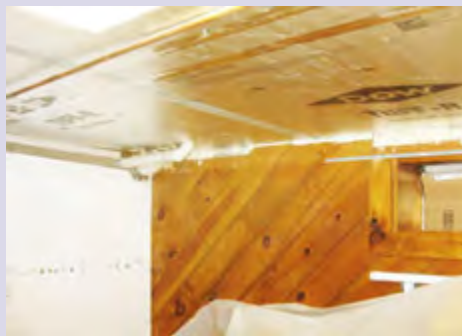
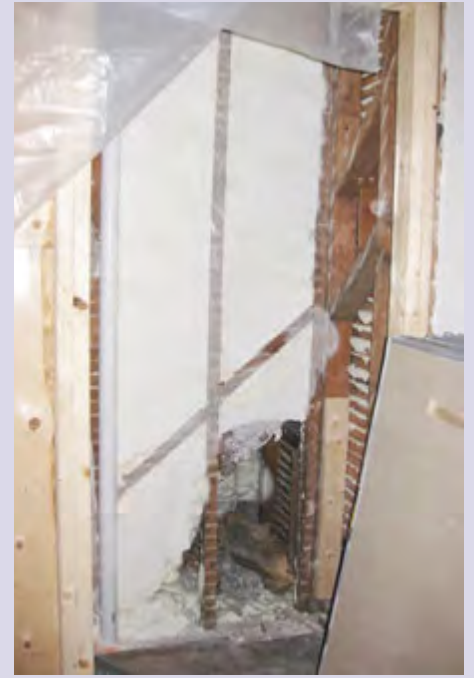
For more information about this or other case studies by Building Science Corporation and the Building America Program go to: www.buildingscienceconsulting.com/services/building-america.aspx

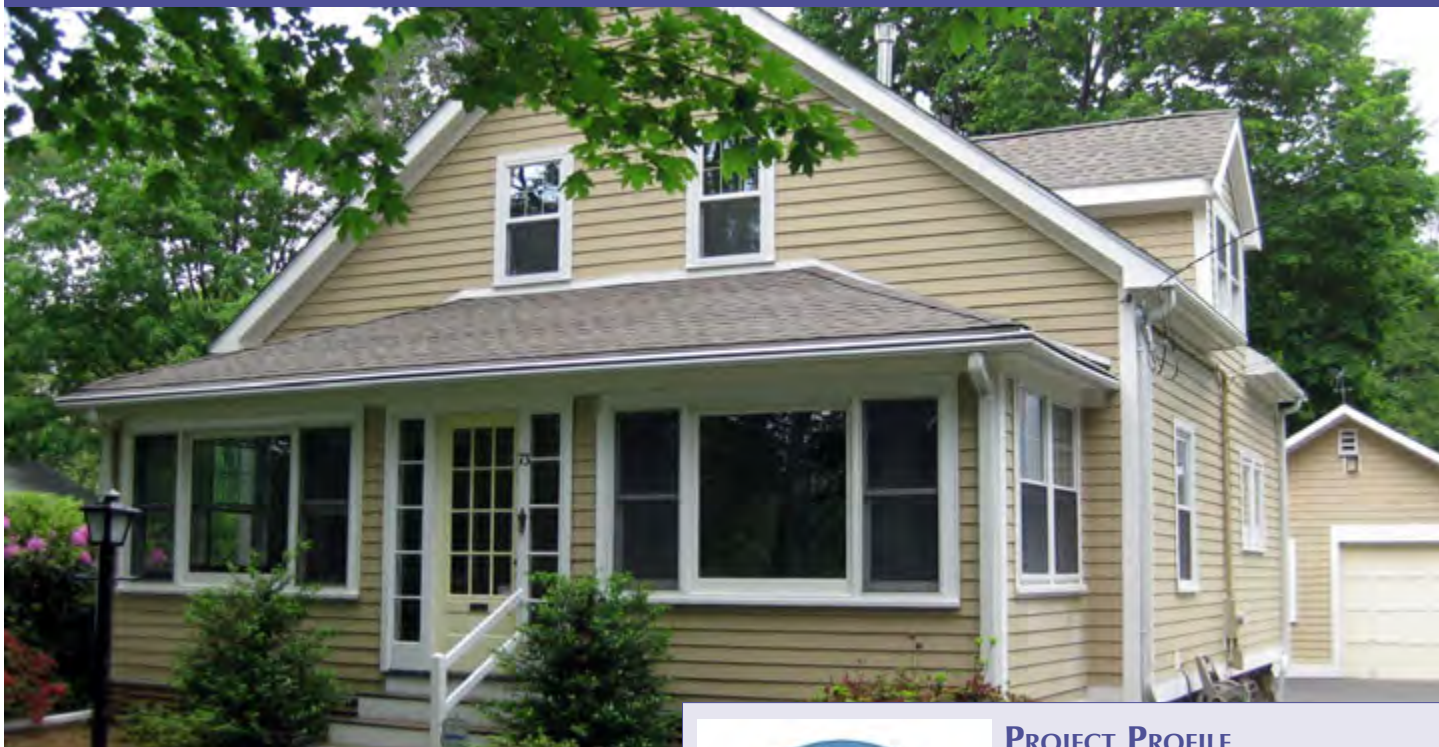
Newton, Massachusetts

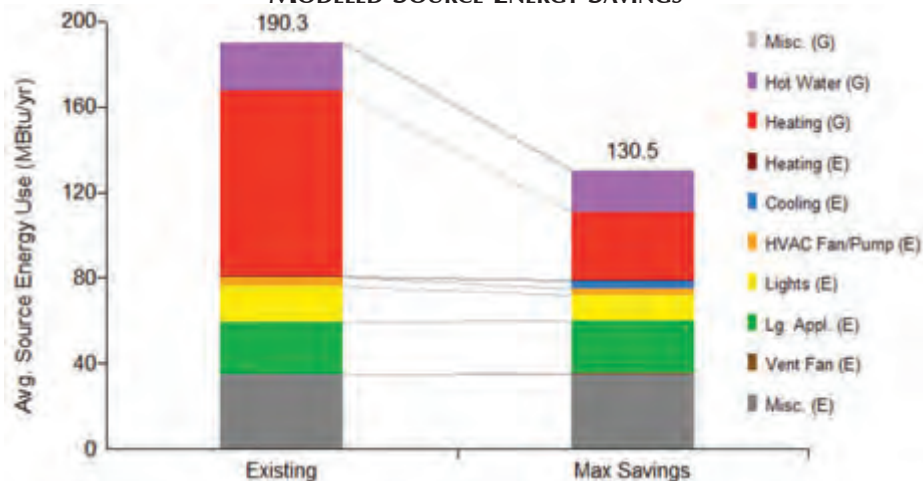
Image from BSC generated by NREL's BEOpt 1.1 for retrofits

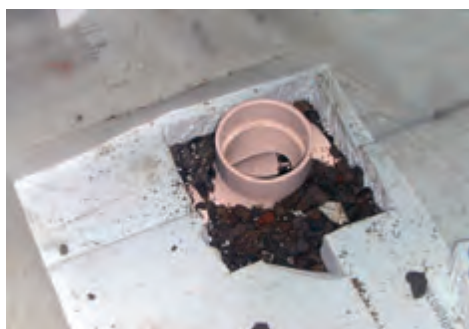
The wall assembly for this project establishes the exterior face of the insulating sheathing as the drainage plane while the housewrap serves as the primary air control layer. The multiple layers of materials in this system provide additional control. The thickness of exterior insulation also places the rain shedding layer further from water sensitive structure.

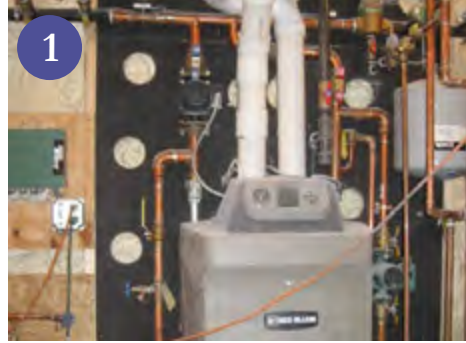
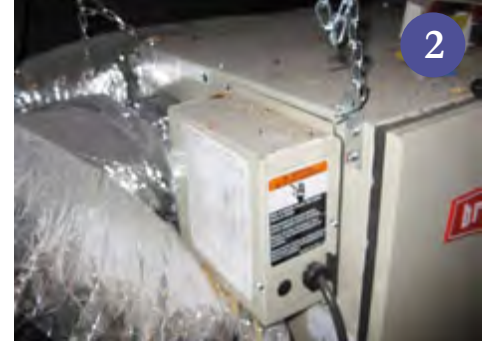
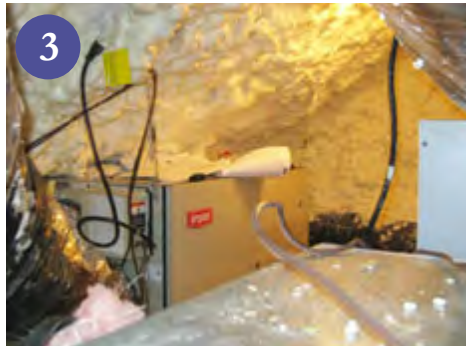
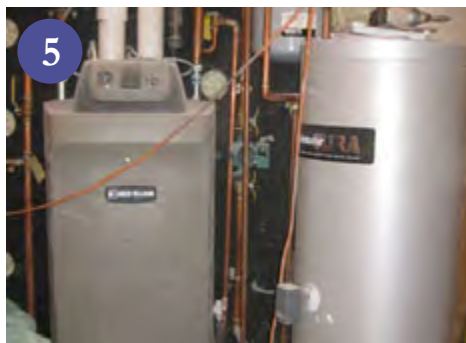
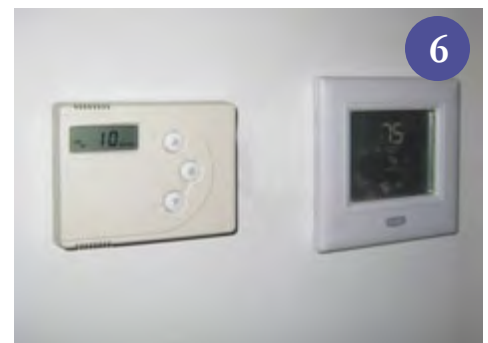
Appliances: ENERGY STAR® appliances.

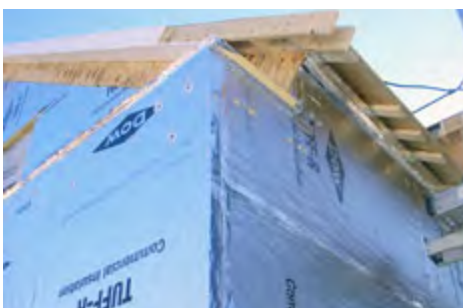
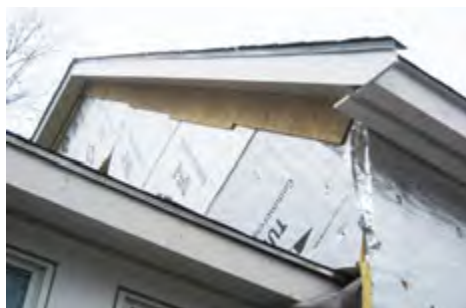
TESTING AND ON-SITE TECHNICAL SUPPORT

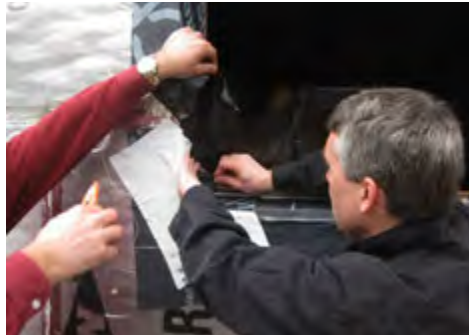
additional site visit to identify major sources of air leakage. With the house alternately depressurized and pressurized, BSC inspected the enclosure with a both a small handheld smoke generator and a larger theatrical smoke machine. While no significant problems were observed in the enclosure construction, BSC did find a problem with outside air dampers on the ERV that requires remediation.

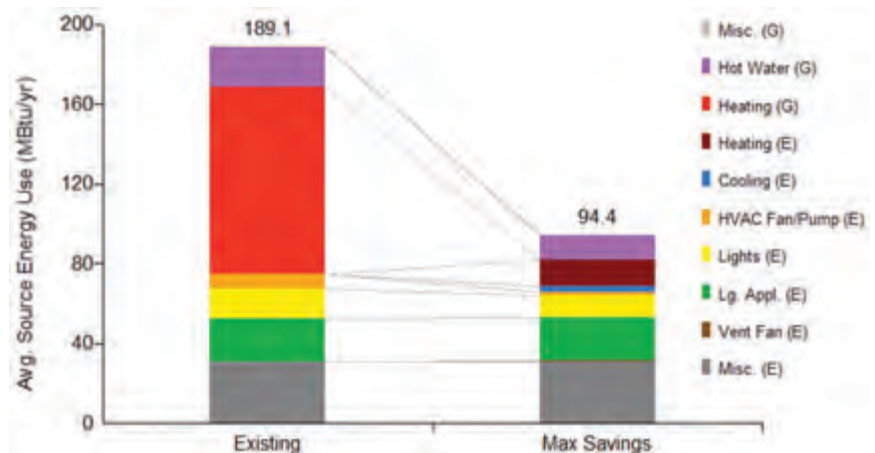
Image from BSC generated by NREL's BEOpt 1.1 for retrofits

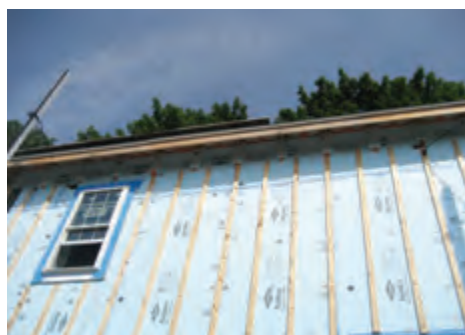
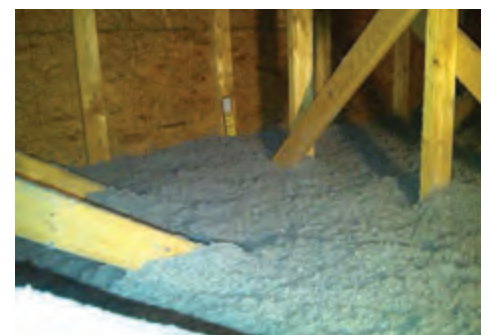
Air flow control at the top of the building is achieved by sealing the perimeter and sealing penetrations at the top floor ceiling. Careful detailing is needed to transition the ceiling air flow control to that of the wall system. A raised heel truss allows the full depth of insulation to continue to the perimeter of the attic. Rigid foam installed up the height of the raised heel protects the ceiling insulation from windwashing or displacement. This approach accommodates very high levels of insulation at a low marginal cost. Mechanical systems and ventilation distribution are located entirely within the conditioned space and not in the vented attic.

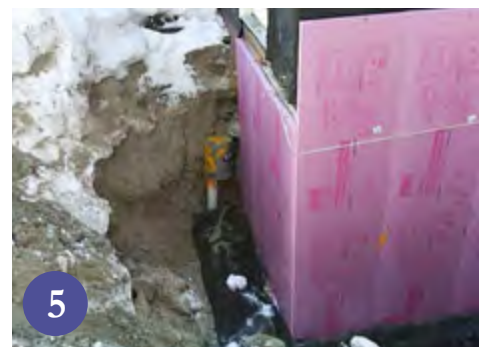
* BSC does not recommend installing a sand layer under new slabs.

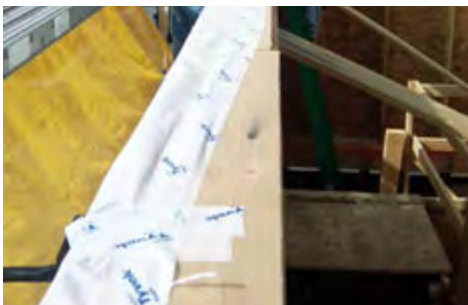
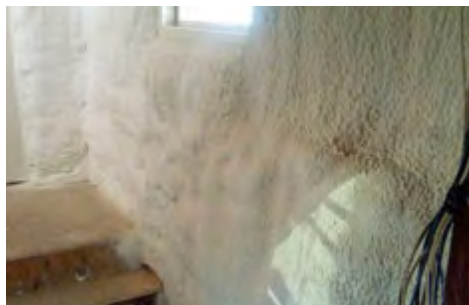
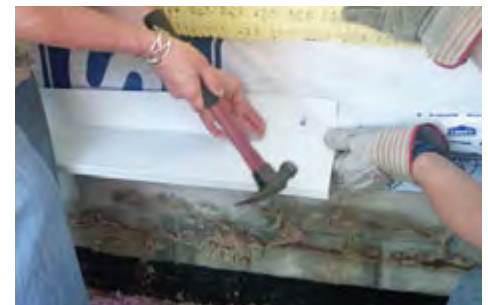
TESTING AND ON-SITE TECHNICAL SUPPORT

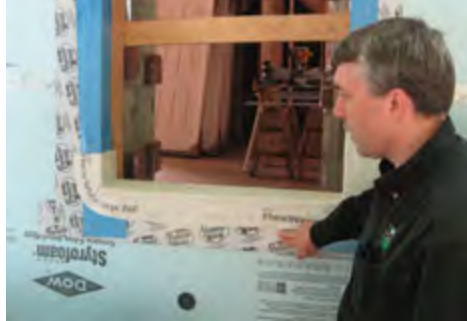
around the house in order to meet the airtightness goal set by the National Grid DER pilot program. The final measurement came in at 1.6 ACH 50!
