BSC Information Sheet 704

What's Wrong With This Project?
Site-Made Beam

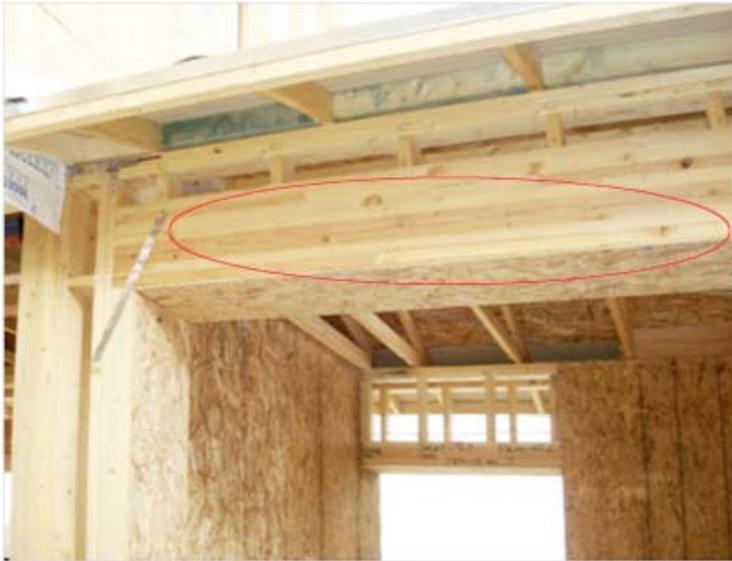
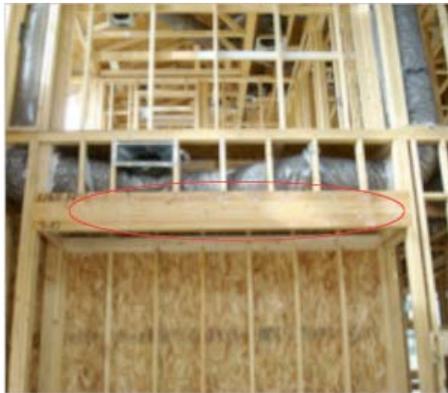
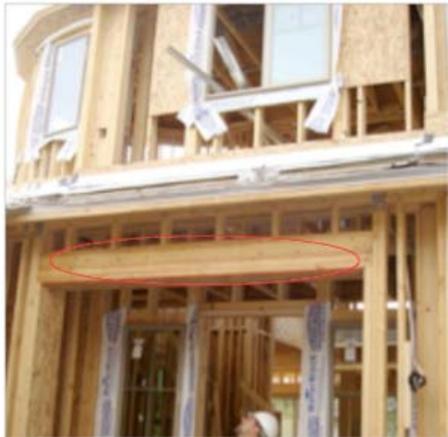
Examples of site-made beams

Site-made beam made by laying framing lumber down on the flat and building it up.

All interior beams in the building were site-made.

Had Advanced Framing techniques been used an overall savings of approximately \$2,000 per building would have been realized. The money could have been available to improve other building components to make them more energy efficient in addition to increasing the builder's profit margin and improving the marketability of the product.

Use a single or double LVL instead and Advanced Framing techniques.
