Joseph Lstiburek, Ph.D., P.Eng, ASHRAE Fellow

## **Building Science**

Towering Inferno

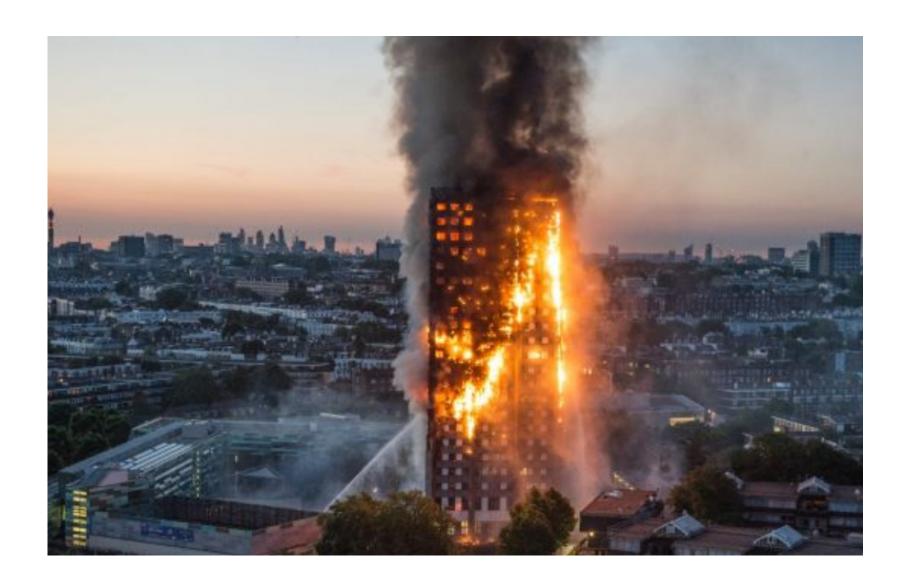
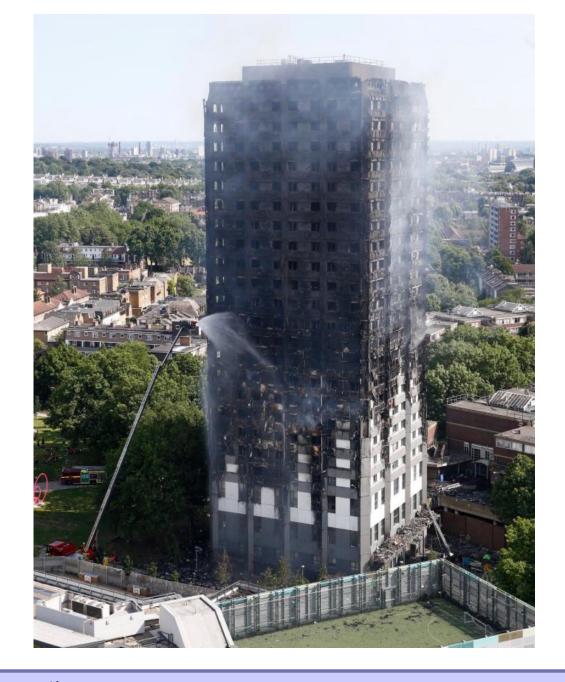
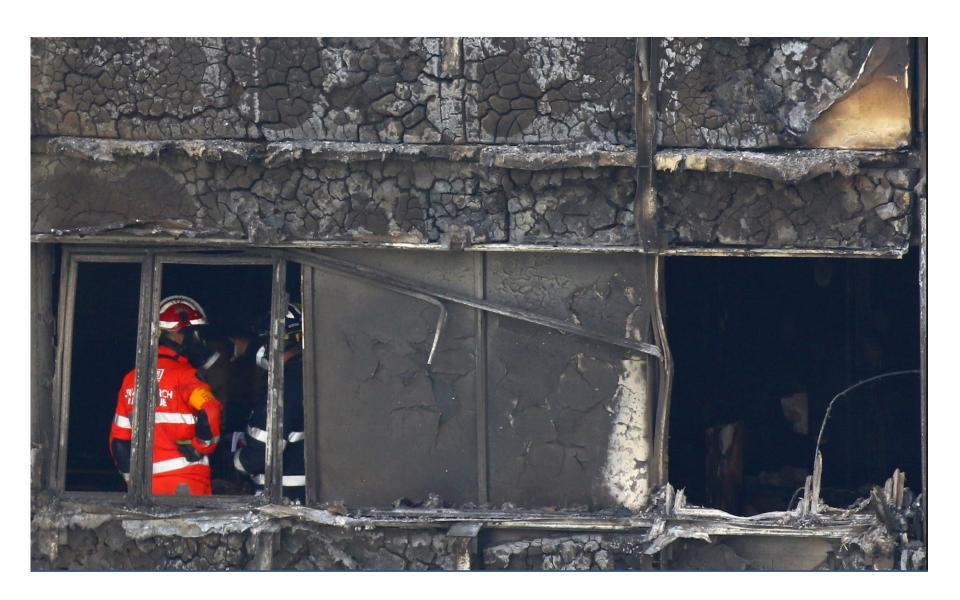
Grenfell Tower
North Kensington, United Kingdom
June, 2017

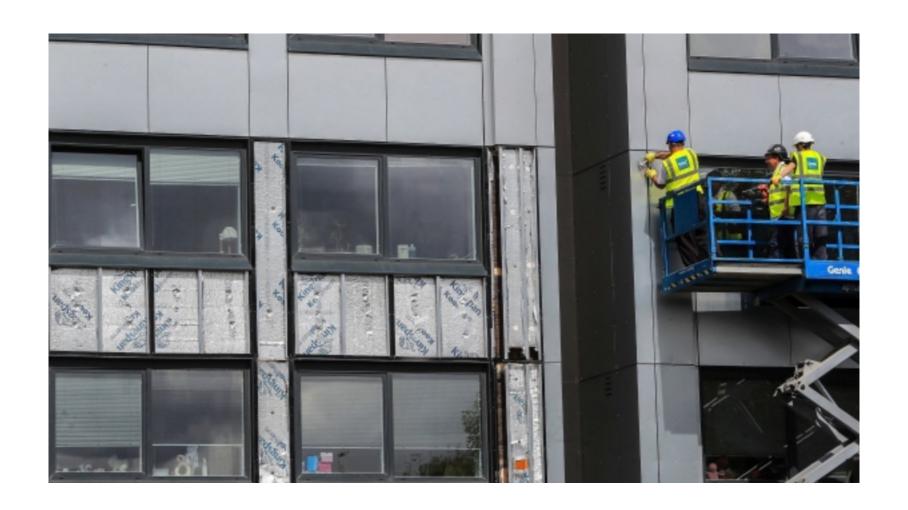
### The English Fix

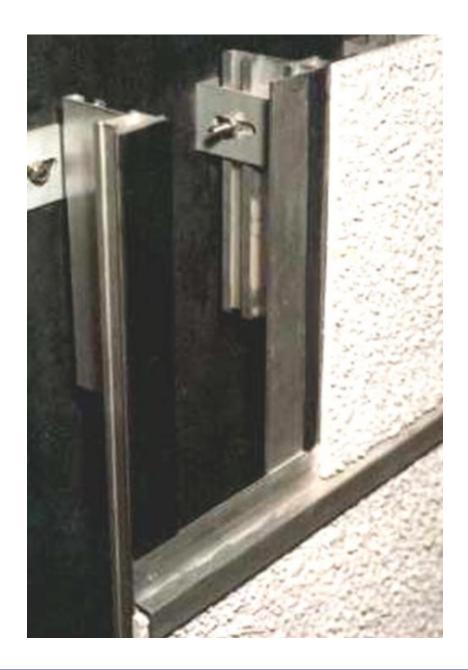
### Cladding Attachment

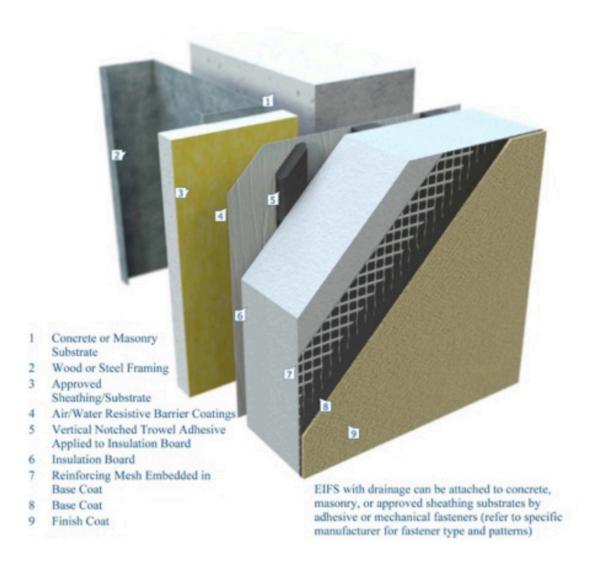
#### TYPICAL EIFS CONFIGURATION
