Corrosion of Galvanized Fasteners used in Cold-Formed Steel Framing

Ian N. Robertson Ph.D., P.E.

Steel Framing Alliance
and
University of Hawaii

November 2000 - November 2004

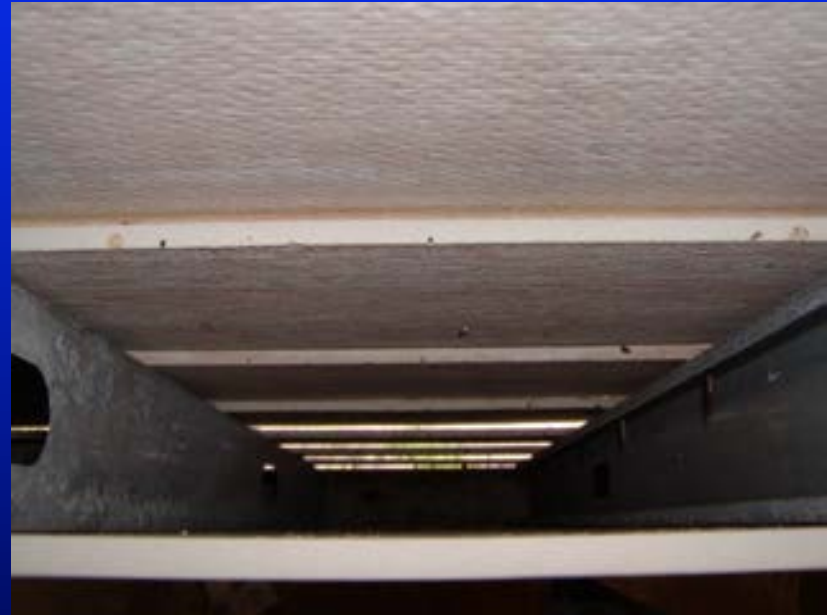
Hardy Board lap-
siding with vapor
barrier

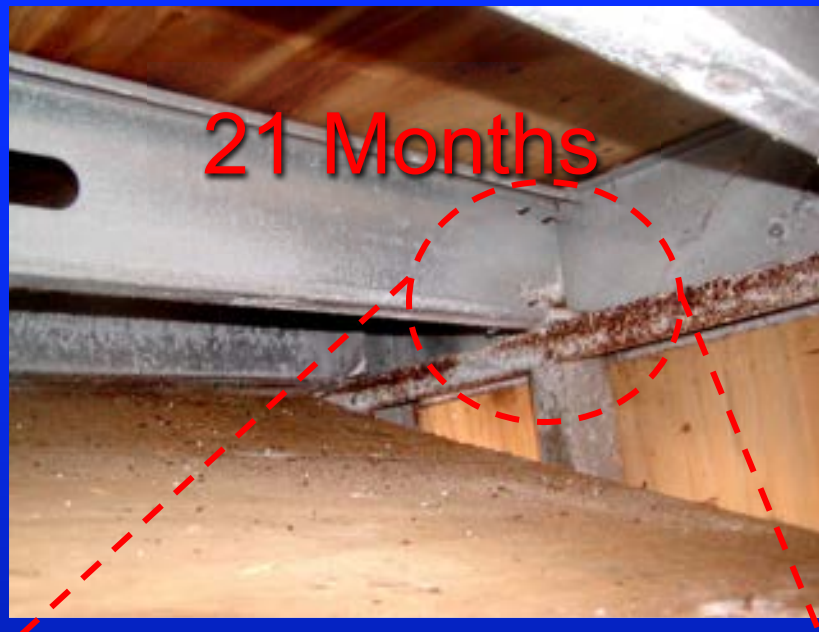
Covered Crawl Space

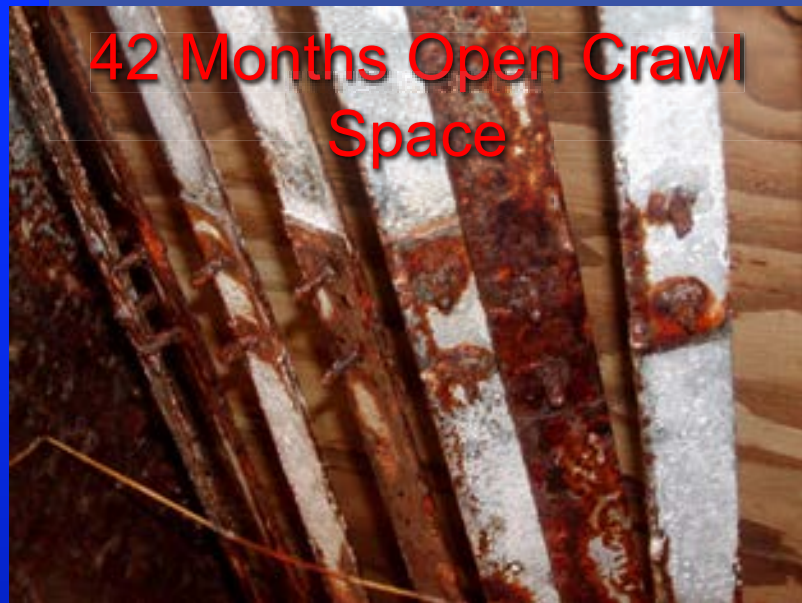
42 Months Open Crawl Space

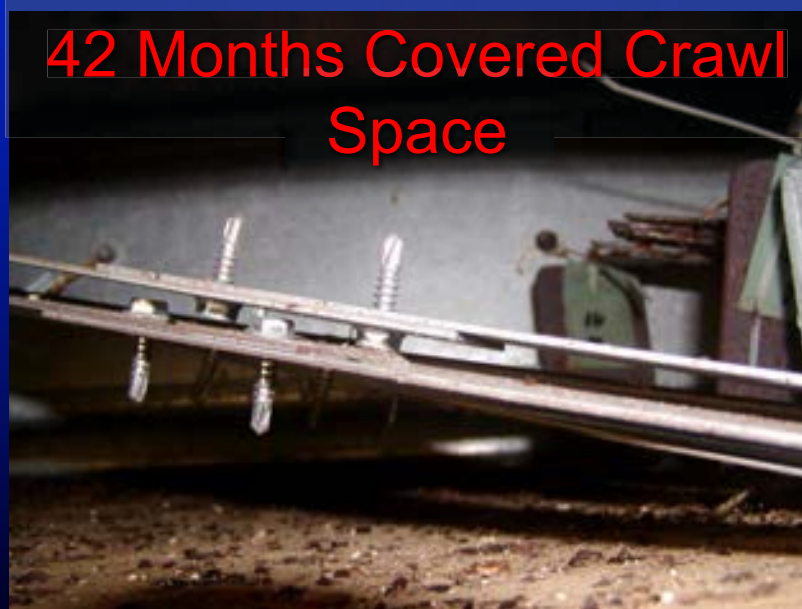
42 Months Covered Crawl Space

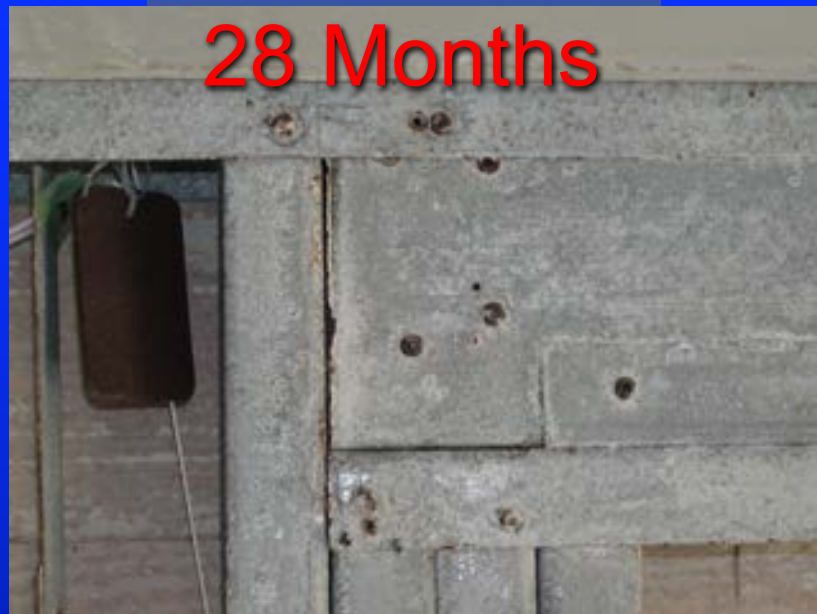
28 Months

Hardie Board without
Vapor Barrier

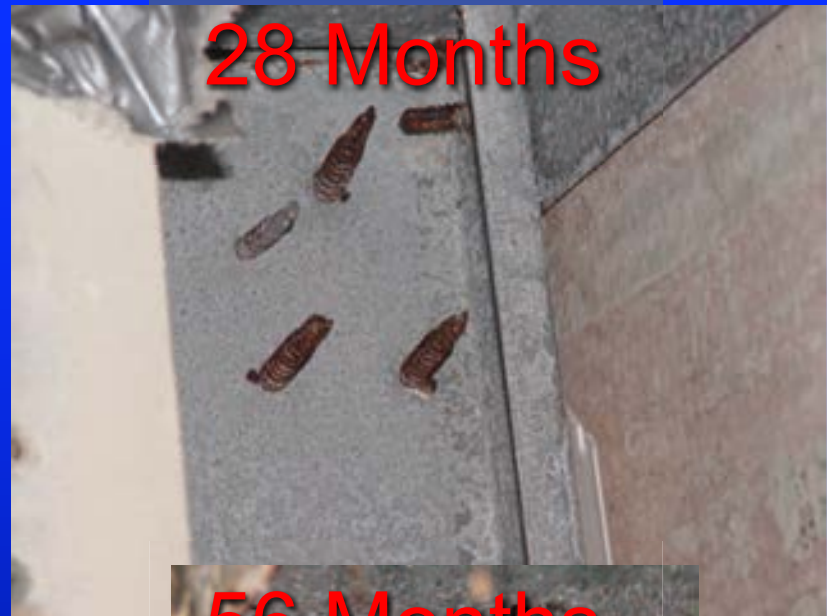
28 Months

Hardie Board without
Vapor Barrier
